**Superfund Five-Year Review Report
Brantley Landfill
Island, Mclean County, KY
EPA ID: KYD980501019**

United States Environmental Protection Agency
Region IV
Atlanta, Georgia

EnSafe, Inc.
Three Centennial Plaza
895 Central Avenue Suite 610
Cincinnati, Ohio 45202

AUGUST 2002

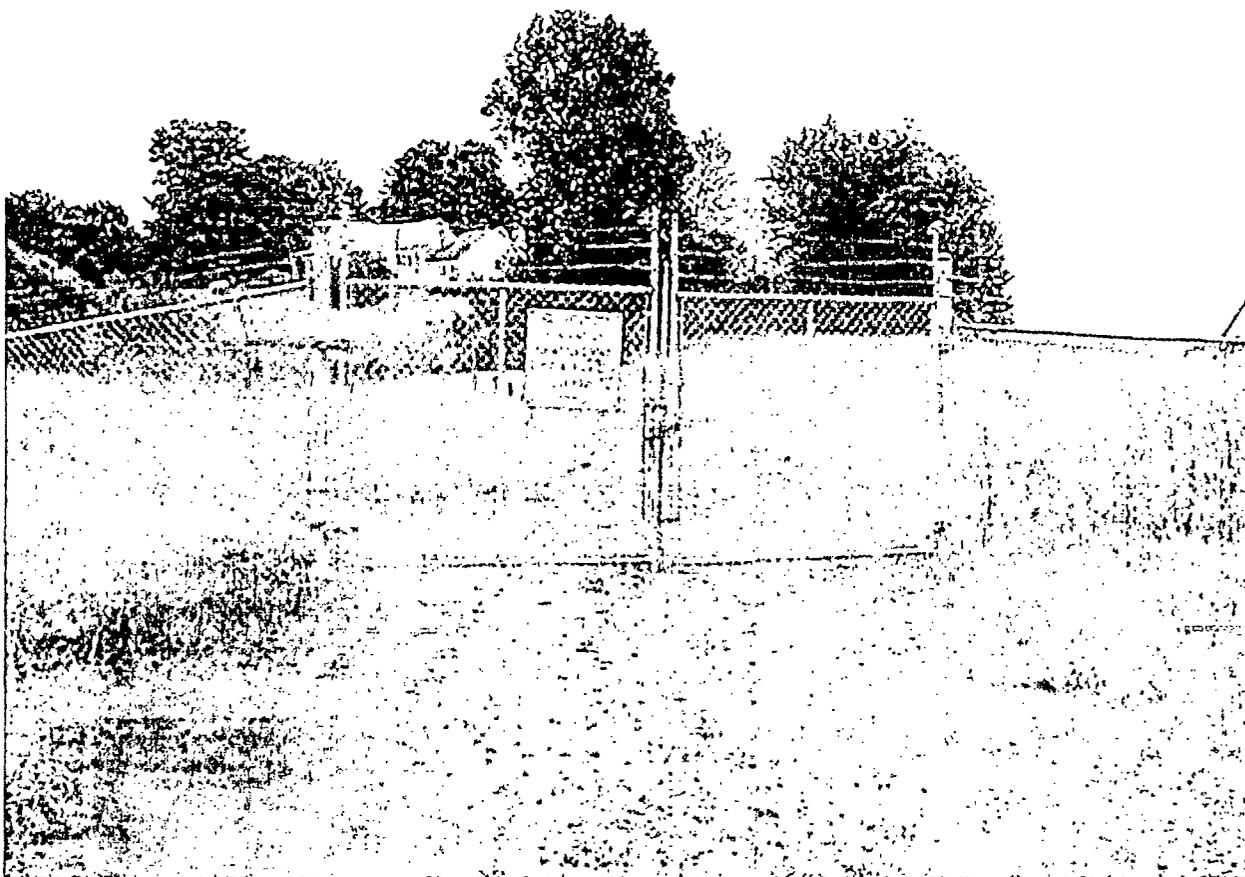
Photograph 1 — Entrance gate to Site. Contact numbers for emergencies/information provided.

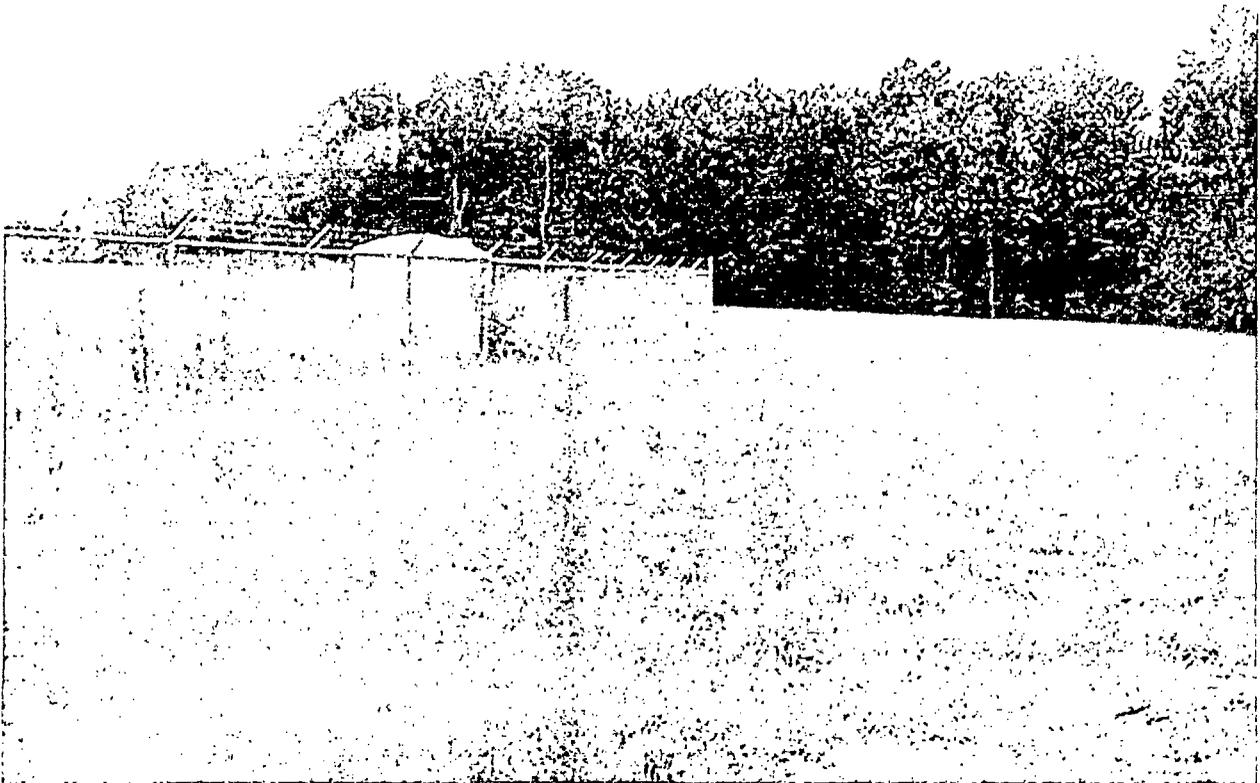
Photograph 2 — Groundwater investigation-derived waste tank along northern fence line.

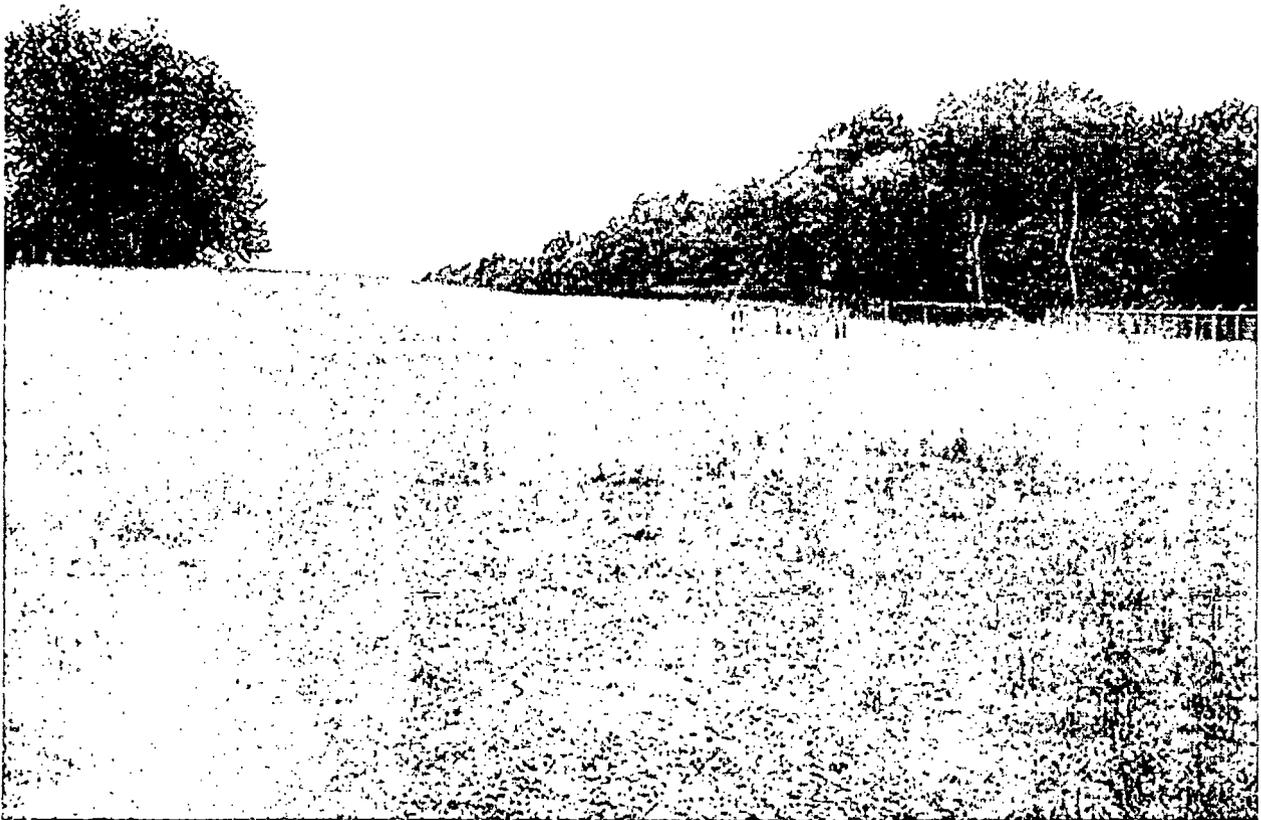
Photograph 3 — View of landfill facing south (inside property boundary).

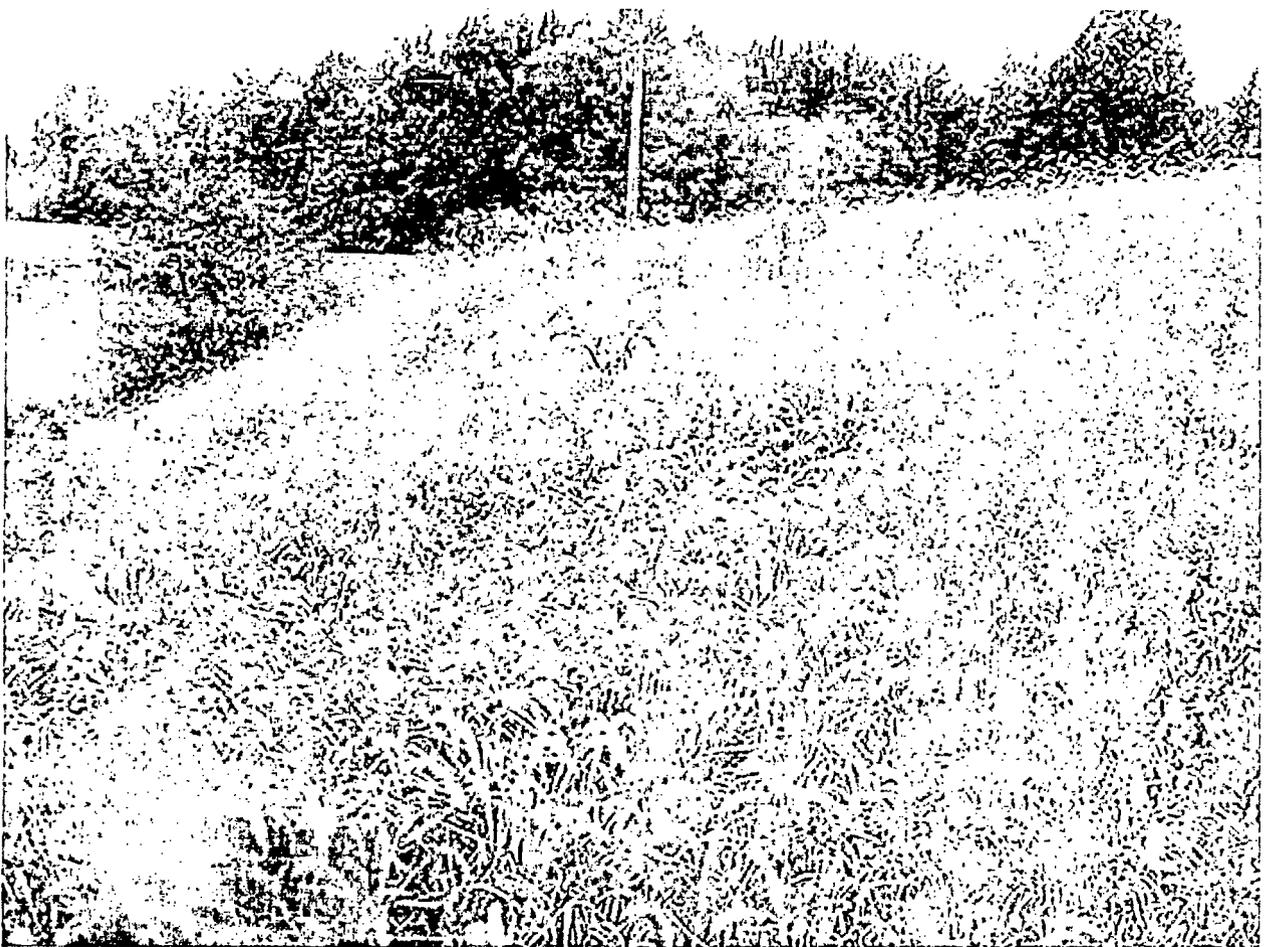
Photograph 9 — Southern slope of landfill. Wastewater treatment plant at left of picture.

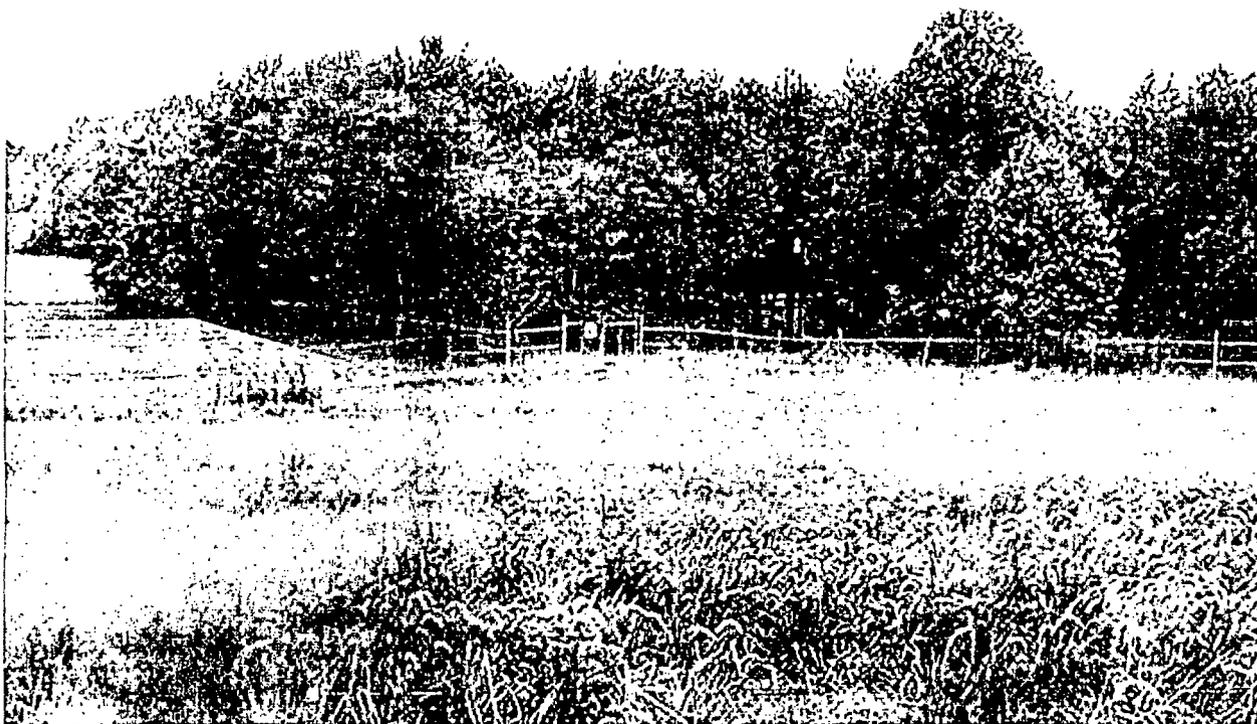
Photograph 10 — Southwestern construction gate and site fence.

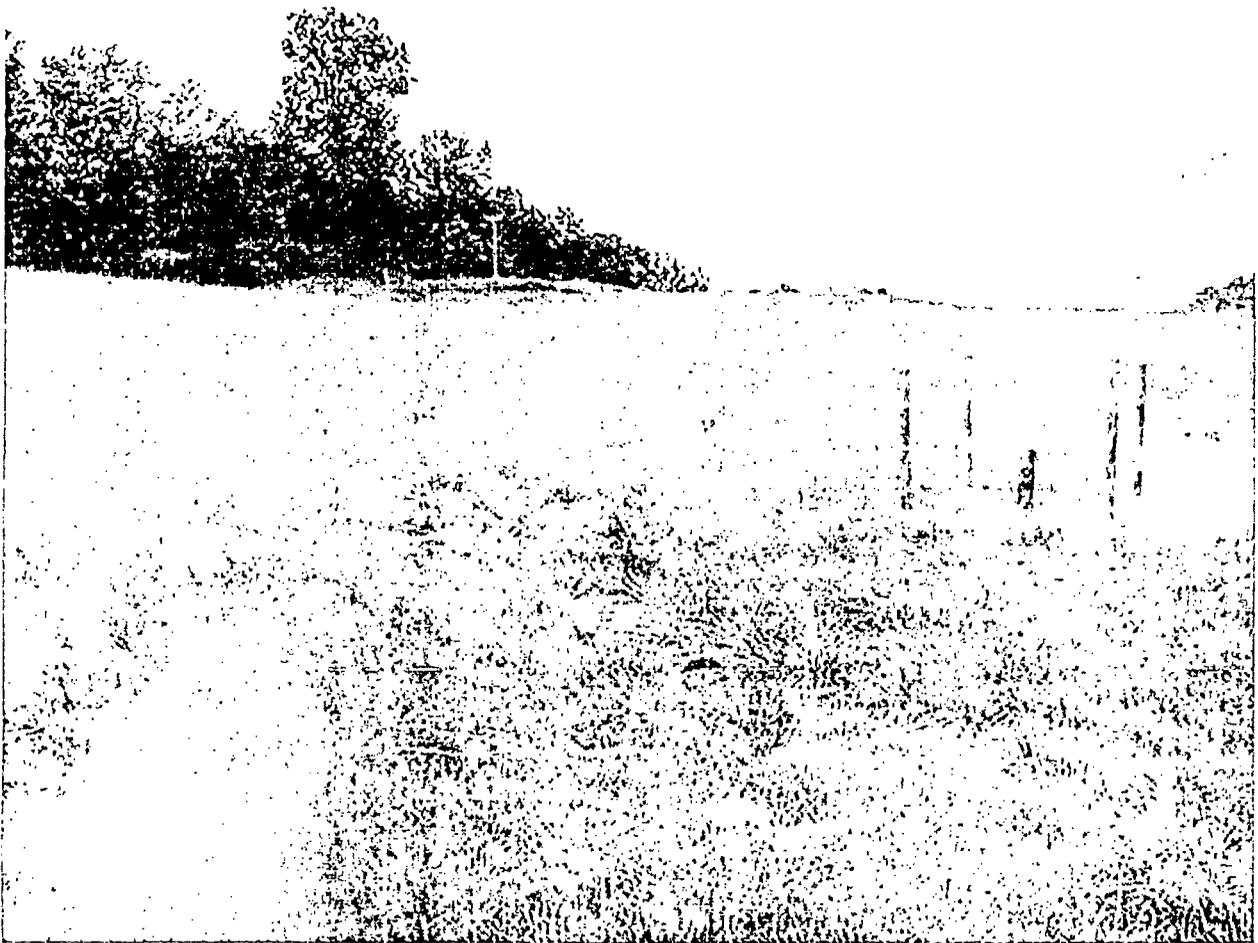
Photograph 11 — Northern perimeter of landfill. Monitoring well ____ at right of picture.

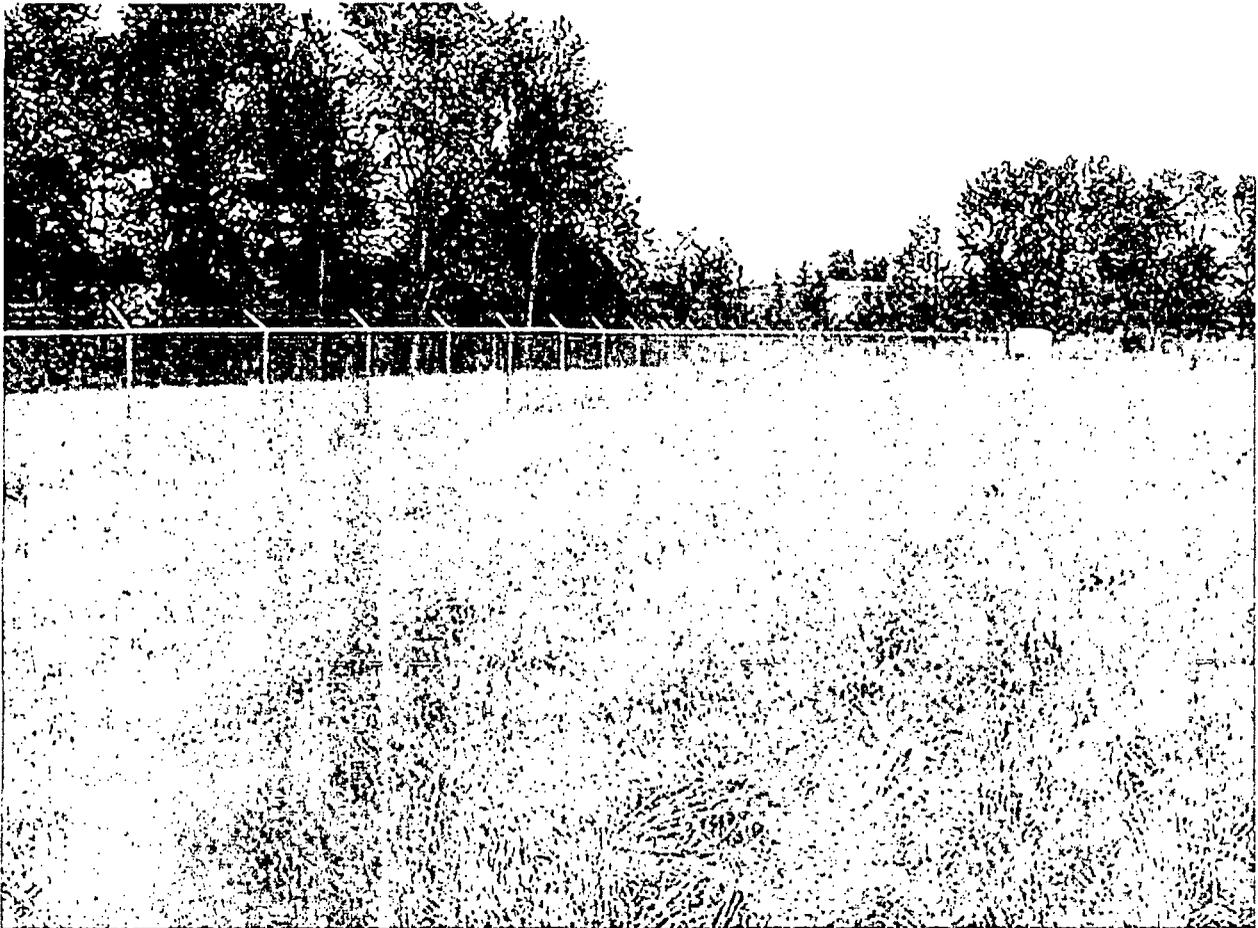
Photograph 12 – Western perimeter fencing at site facing North.
