This issue of **Technology News & Trends** highlights how remedies for contaminated sites may be vulnerable to the impacts of climate change and how measures may be taken to adapt remedies to the impacts. Potential impacts include extreme or sustained changes in temperatures, increased flood events or droughts, increased wind intensity, more frequent and intense wildfires, and sea level rise. The U.S. Environmental Agency (EPA) Superfund program has developed an approach that raises awareness of the vulnerabilities and applies climate change science as a standard business practice in site cleanup projects. Articles featured in this issue examine vulnerabilities at three National Priorities List sites, describe the effects of intense weather events at these sites, and detail adaptation measures already implemented or planned to increase the remedies' resilience to climate change impacts.

Site Operations and Remedy Design: Hurricane Irene Flooding and Adaptation at the American Cyanamid Site

Remedy Performance: Remedy Resilience to Flooding at the Rocky Mountain Arsenal

Remedy Design: Long-Term Protective Measures Against Storms and Flooding at Allen Harbor Landfill

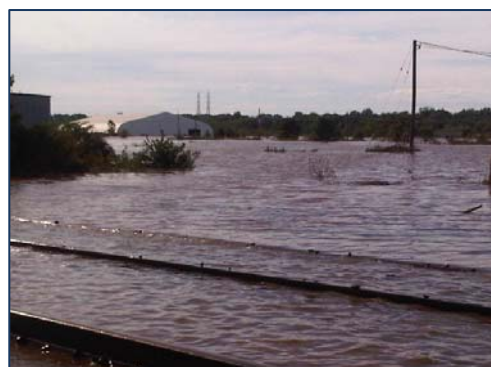
Figure 1. Raritan River from its typical elevation of approximately 18 feet above mean sea level to an elevation of 42 feet during Hurricane Irene, which inundated the north area of the American Cyanamid site with five feet of standing water after floodwaters receded.

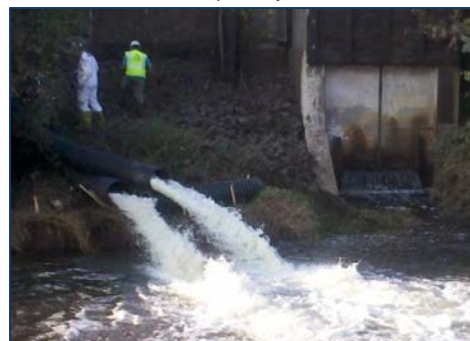
Floodwaters entering the site were prevented from exiting due to an inoperative mechanical sluice gate, which created a "bathtub" within the 10- to 12-foot flood control berm of the 268-acre north area. After analyzing samples of the standing floodwater, it was determined that the controlled release of the floodwater into the adjacent Cuckel's Brook would not negatively impact its water quality. By September 28, approximately 152 million gallons of floodwater had been discharged to the brook (Figure 2) using generator-powered pumps

Figure 2. Controlled release of floodwater into Cuckel's Brook at a rate averaging 5,200 gallons per minute, at a location close to the former sluice gate discharge point.

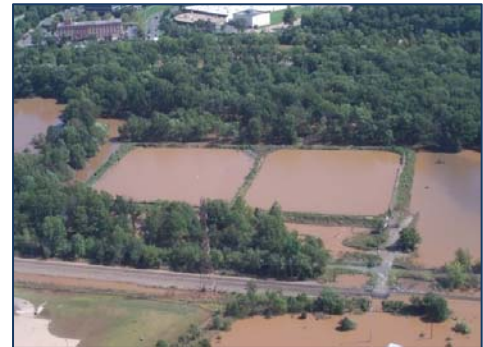
The potential for a surficial release or catastrophic failure of the berms surrounding impoundments 1 and 2 was a concern during the flood (Figure 3). These impoundments are located in the site's south area, approximately 700 feet from the river and outside of the site's flood control berm. Unreinforced earthen berms were constructed around the two adjacent impoundments in the mid 1900s to contain waste and control floodwaters. Before the floodwaters receded, surface water samples were collected from standing water in the vicinity of the impoundments and from downstream points of the Raritan River. Results from the post-flood surface water sampling and berm inspections indicated that a significant release did not occur.

Figure 3. Area comprising impoundments 1 and 2 that remained flooded two days after the peak of Hurricane Irene flooding.

Adaptation measures implemented to reduce the vulnerabilities of impoundments 1 and 2 included installing new HDPE covers on the impoundments to reduce the potential for waste mobilization during floods, as well as reinforcing the berms to increase their strength and prevent

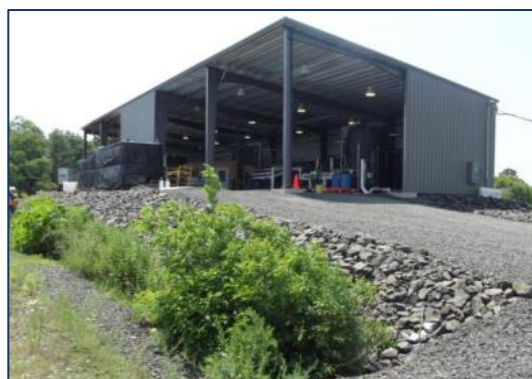
Figure 5. Elevated groundwater treatment plant constructed as part of an EPA removal action; the treatment process includes metals precipitation, filtration and carbon adsorption.

The site's groundwater extraction system has also been adapted for the increased frequency of major flood events. Both of the existing turbine pumps used to extract groundwater for offsite treatment were replaced with submersible pumps designed to allow for uninterrupted pumping during future floods. In April 2012, an interim onsite groundwater treatment system was constructed to treat groundwater captured by a collection trench intercepting discharges to the Raritan River. The treatment system was constructed at an elevation more than 1 foot higher than the flood levels experienced during Hurricane Irene (Figure 5).

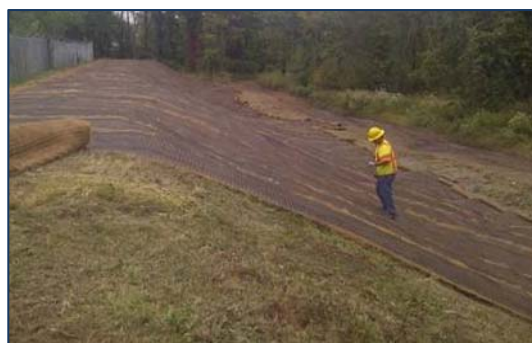
Figure 6. TRM strips approximately 6.5 feet wide deployed vertically along the outer portion of the berms surrounding impoundments 1 and 2 and anchored with metal pins prior to revegetation.

flood-related scouring. A high-strength, ultraviolet-stabilized, multi-layered synthetic matting with a fiber matrix material (commonly known as a turf reinforcement mat [TRM]) was installed on the berm banks to serve as a soft armor for erosion control and vegetation stability (Figure 6). The TRM is designed to withstand water velocities in excess of 8 feet per second.

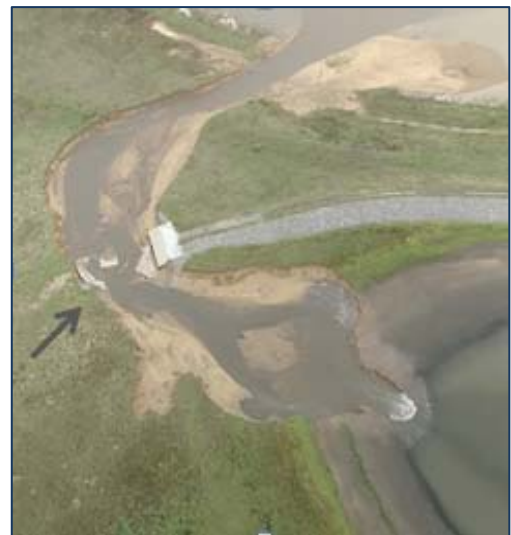
On September 12, stormwater surging onto the arsenal caused a breach of the downgradient Denver-owned Havana Ponds dam inside the wildlife refuge (Figure 1). Associated currents carved an 8-foot-deep gully through the refuge and washed out roads, trails and other local infrastructure. More than 400 acres of the refuge were submerged

Figure 1. Overflow of the arsenal's network of stormwater holding ponds due to record-breaking rainfall and subsequent rupture of the Havana Ponds dam used for controlled release of the stored water.

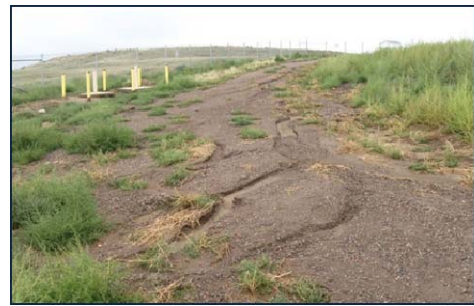
Overall, the arsenal suffered more than \$20 million in damage caused by the flooding. Post-storm assessments indicated that the two capped landfills were relatively resilient to the flood; both were designed to withstand a 1,000-year, 24-hour storm event. During the flood, sheet flow from the rock-amended soil on the RCRA-Subtitle C landfill caps drained to the concrete block channels as anticipated, with minimal development of erosion rills (Figure 2) and only minor sediment accumulation at the channel ends (Figure 3). Additional sediment accumulated in leachate-riser control buildings above one landfill but caused no damage to the instrumentation, pumps or auxiliary systems. Small graders were used to remove the accumulated sediment within one week of floodwater peak.

Figure 2. Rill erosion at the capped landfills, primarily on access roads.

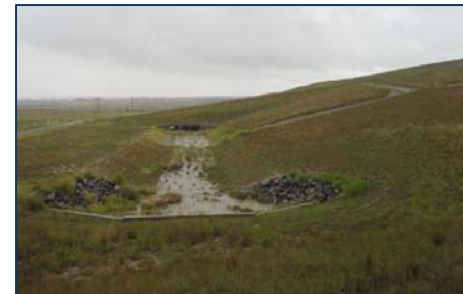
Figure 3. Stormwater runoff carrying loose sediment, which settled within downgradient ends of the concrete drainage channels.

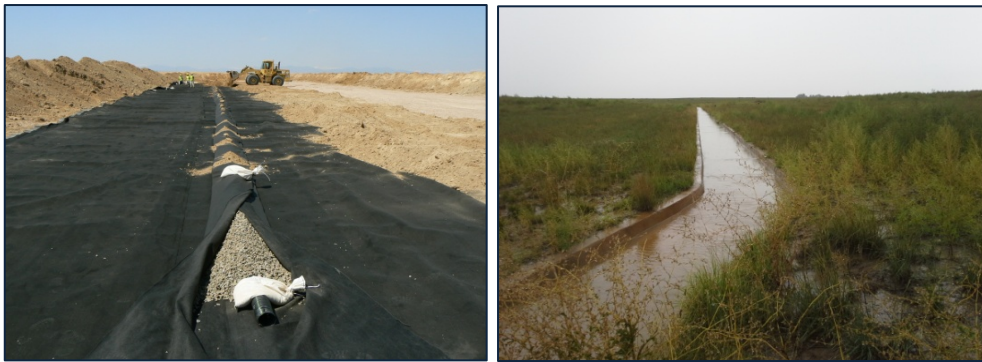
Also, erosion controls for the RCRA-equivalent covers were designed to limit overland flow lengths to 500 feet, which minimizes rill and gully formation. Their designs reflect an overall slope of 3 percent in a "broken back" configuration involving drainage channels cut through the covers (Figure 4). A total of 2.5 miles of drainage channels, ranging from 150 to 2,246 feet in length, were installed at grades of 0.3 to 1 percent across the 450 acres. The covers' ability to withstand extreme wind and precipitation and related erosion is reinforced by their ground surface vegetation. It comprises a diverse mixture of shallow- and deep-rooted native plants intended to maximize water removal and increase resilience to indirect effects of a changing climate; effects could involve pathogen and pest outbreaks or land surface disturbances such as wildfires and wildlife overgrazing.

Figure 4. Broken-back design and low-slope drainage provided by 6-inch-diameter slotted pipe secured beneath 4 feet of soil overlain by concrete channeling; the September stormwater drained effectively through the channels, despite heavy saturation of surrounding soil.
