Iron Mountain Mine Superfund Site Long Term O&M Challenges

James Sickles, U.S. EPA Region 9

National Conference on Mining-Influenced Waters:
Approaches for Characterization, Source Control and Treatment
Albuquerque, New Mexico

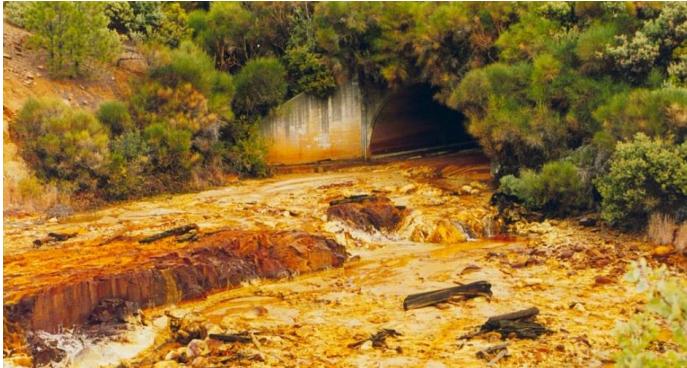
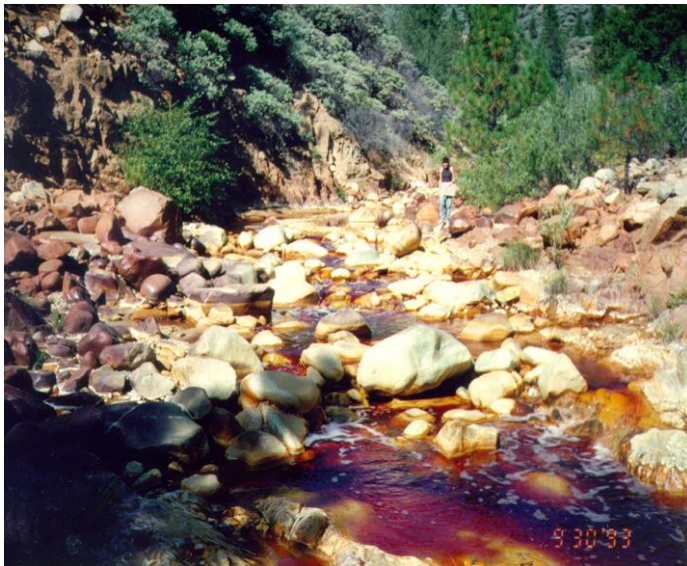
- Mining influenced waters (MIW) with pH as low as -3.6 found in Richmond Mine workings
- 10,000 pounds of iron, 650 pounds of copper, and 1,800 pounds of zinc were discharged per day prior to remediation
- AMD entering Keswick Reservoir precipitated more than 200,000 cubic yards of metal rich sediment into the Spring Creek Arm

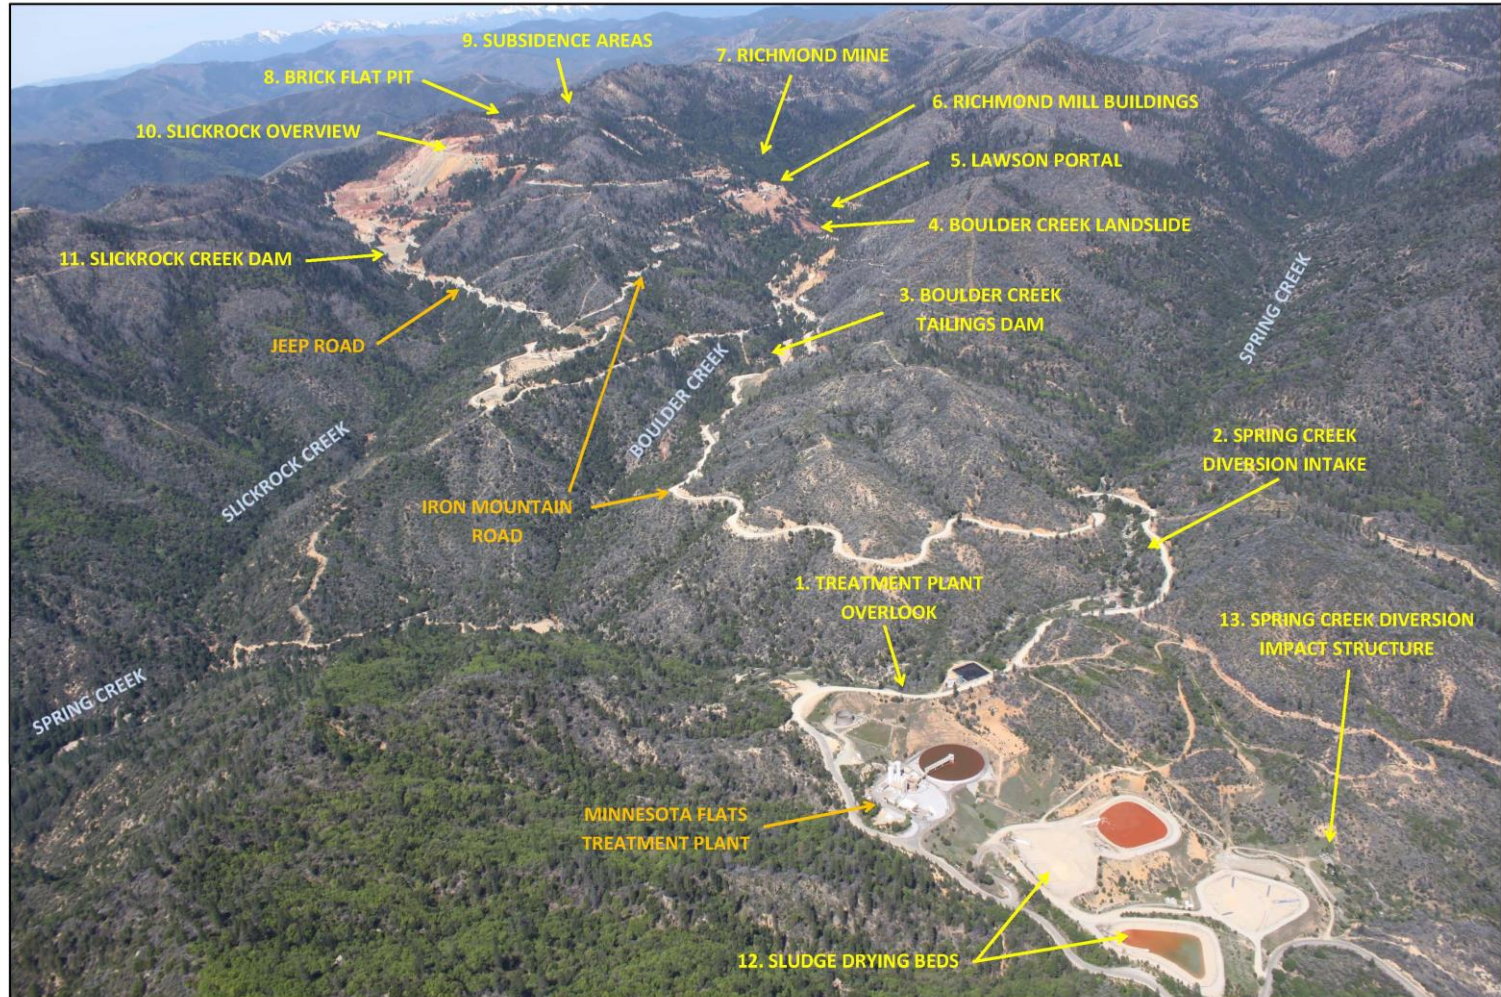
Site Remedial Components:

1. MIW collection systems – sumps, subsurface drains in the Richmond and Lawson adits, extraction wells, surface water retention reservoir and surface water controls;
2. Conveyance systems – HDPE pipelines to Minnesota Flats Treatment Plant;
3. Clean water diversion systems – tunnels and pipelines;
4. Mine waste disposal facilities – Brick Flat Pit, waste rock cells, and a confined disposal facility for dredged material from Keswick Reservoir; and
5. MIW treatment plant – lime neutralization/high density sludge (HDS) facility at Minnesota Flats.

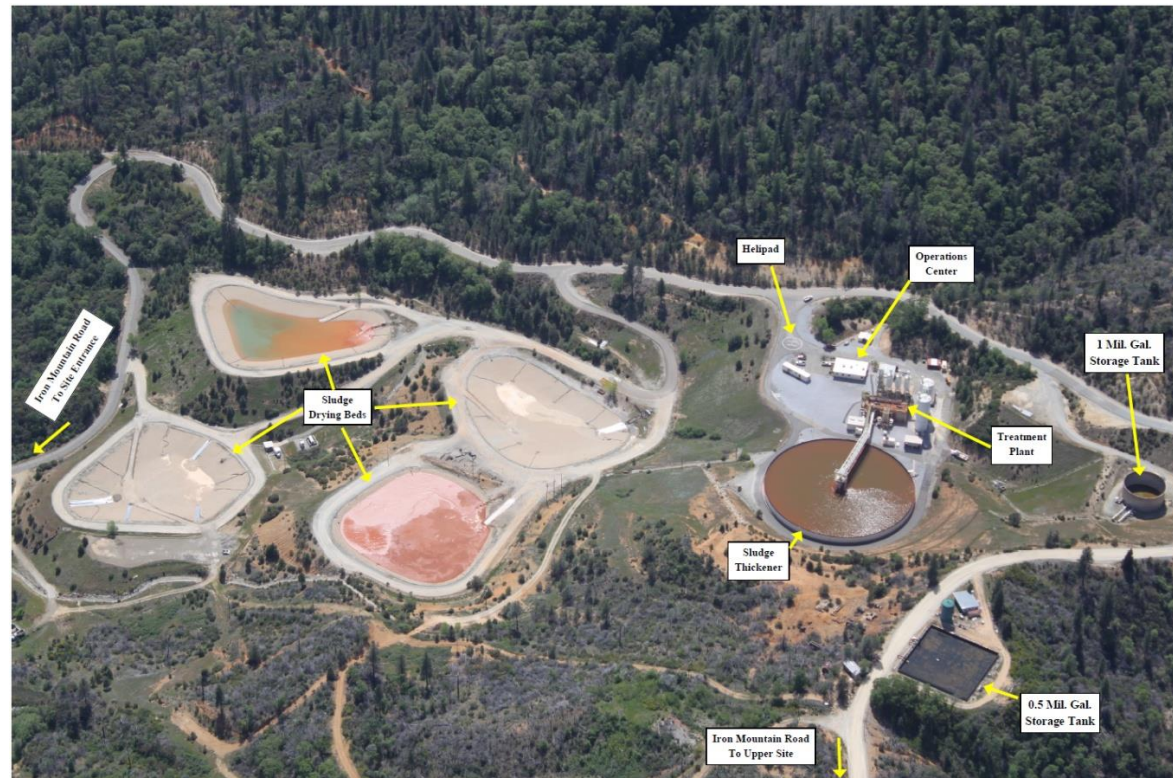
- Lime neutralization/high density sludge plant – design capacity of 6,500 gpm (53.5 million gals per day)
- 280 foot diameter thickener tank – Plant generates approximately 20,000 cubic yards of HDS per year that is placed in Brick Flat Pit
- The plant has a 1 million gallon AMD emergency storage tank that can handle 2 weeks of flow in the summer and less than a day in large winter storms

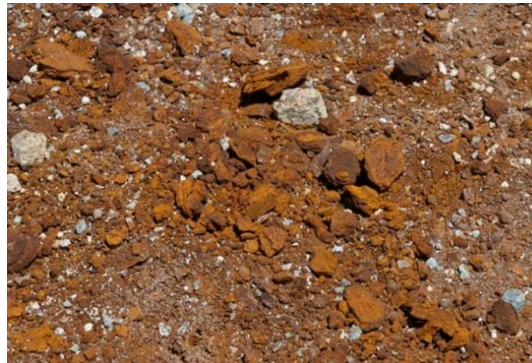
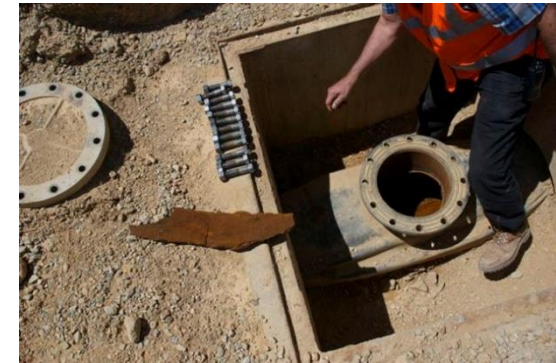
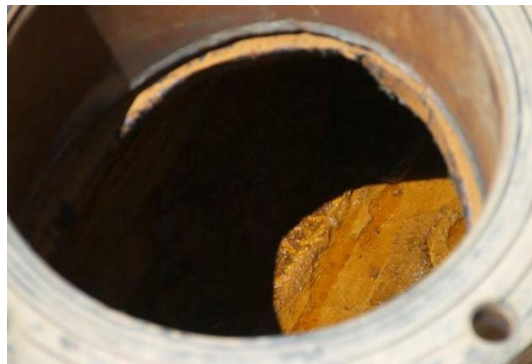
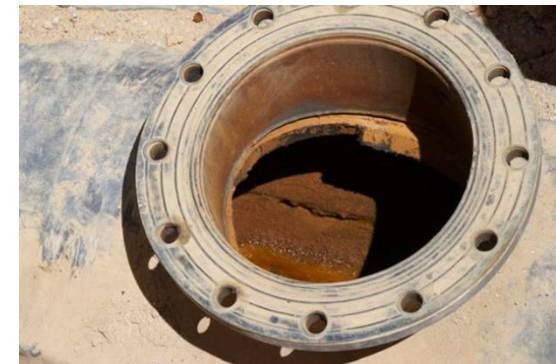
- Pipe scale formed by varying pH in MIW due to microbial oxidation of $Fe(II)$ in piping scale, as has been shown by USGS research, which will be discussed in the next presentation
- Precipitation of scale occurs in short time frame, reduces up to 40% of pipe capacity causing blockage and releases through air vents
- Traditional cleaning methods problematic due to HDPE piping and burial of piping distorting pipe shape

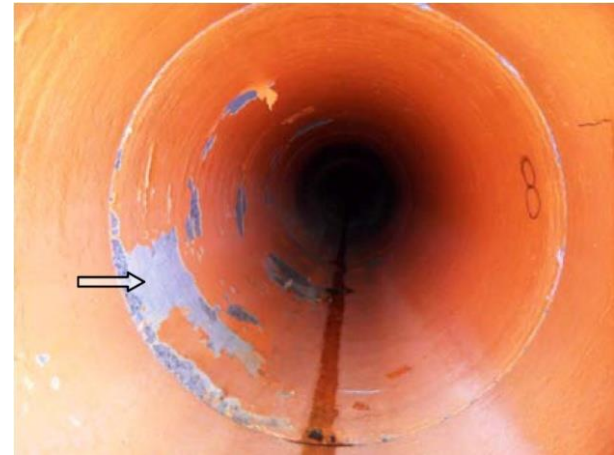
- Diversion is 1,200 feet long unlined concrete arch tunnel and reinforced concrete pipe
- Diversion system drops 280 feet in elevation from upper Spring Creek to Flat Creek – designed to convey 800 cubic feet per second (cfs)
- Flow velocities at 800 cfs range from 15 feet per second (fps) to 70 fps. Usual design flow is 15 fps
- High flow velocities in winter storms result in abrasion-erosion and cavitation with loss of cement up to 1 ¼ inch and lining failures of up to 40%

Liner Failure in Pipe

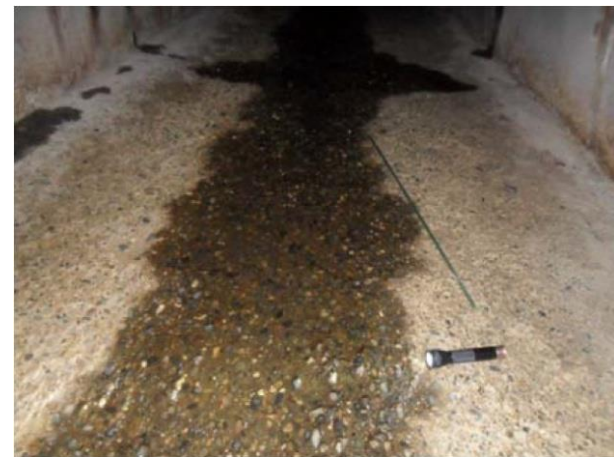
Erosion of Concrete Approximately 1" Deep

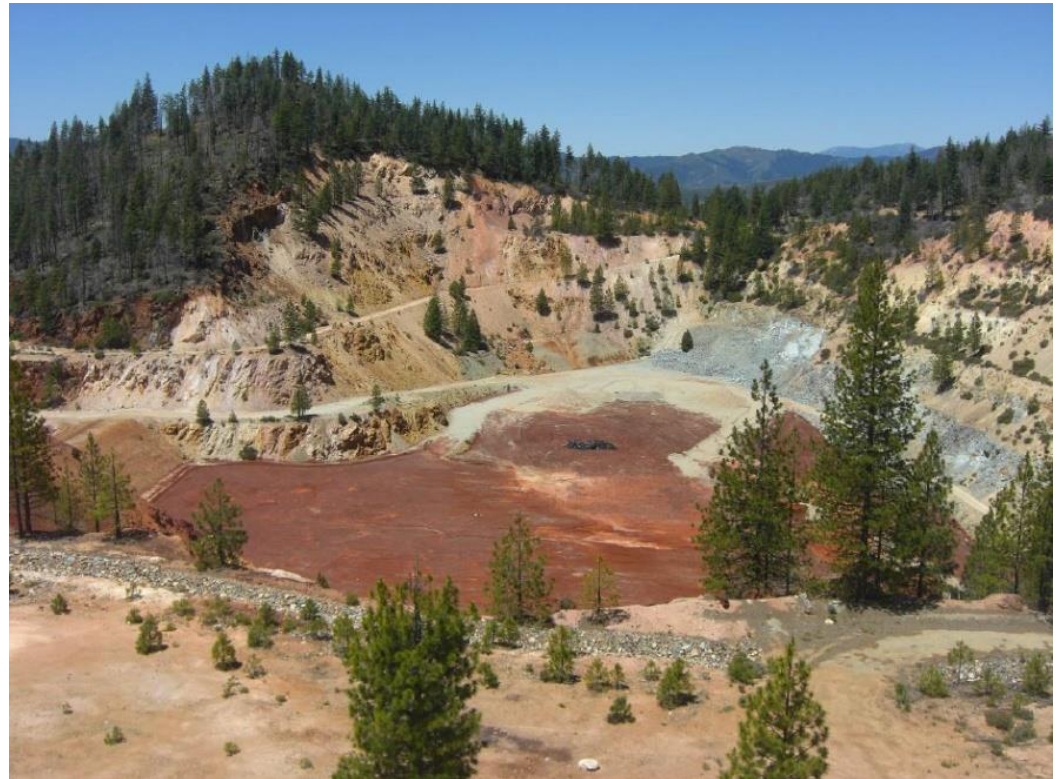
- Brick Flat Pit was first lined in 1989 and designed to place waste materials from site. It was expanded in 1993-1994
- Currently estimated to cover 44 acres and contain 494,000 cubic yards of sludge with a depth of 80 feet
- At the current fill rate of 20 to 25,000 cubic yards per year; a third phase of the containment dam will be needed to allow another 150 years of use

- Filtrate flow in 2004 dropped from up to 100 gpm discharge to a trickle during winter operations
- Summer 2004 tracer study and investigation have not been able to trace leakage – assumed to be leaking through fractured rock in unlined side walls of pit
- Investigation into loss of filtrate being evaluated to determine path of leakage and how to address in needed

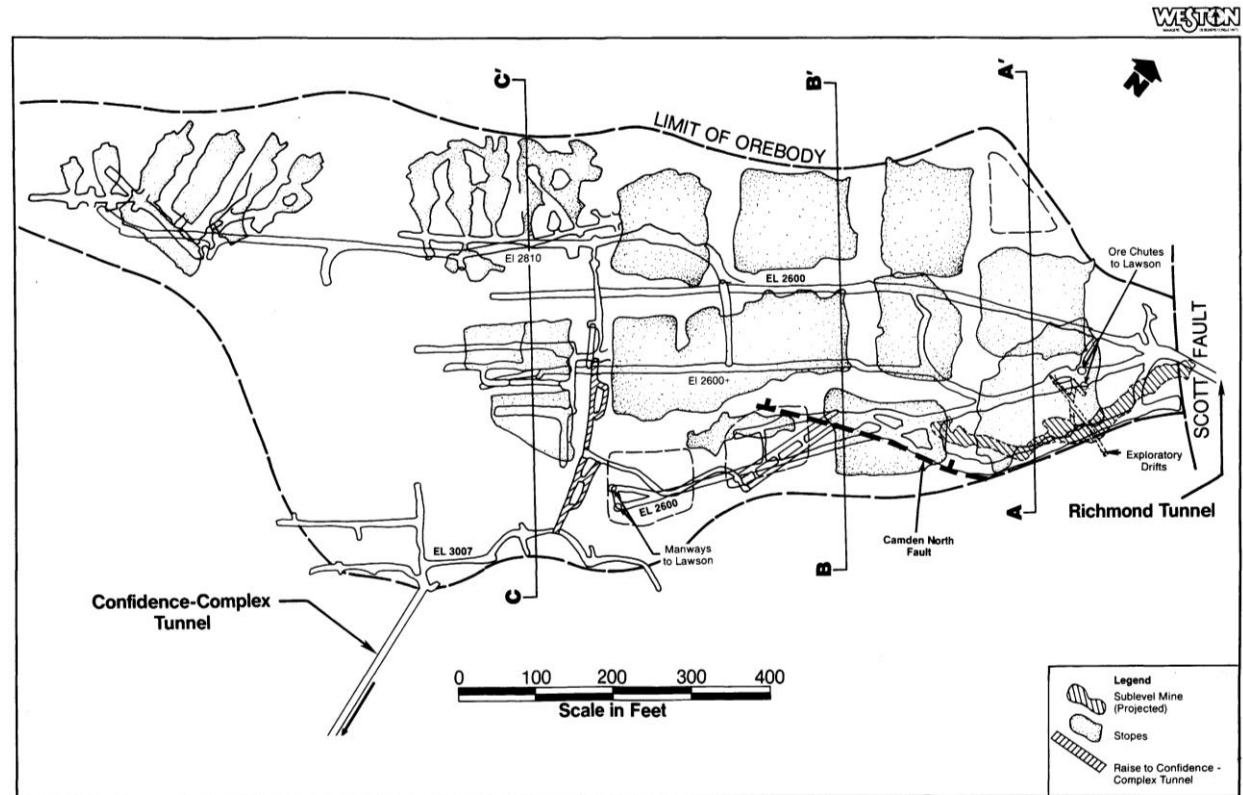
- Drifts A,B, and C are flat at the 2,600 level with multiple chutes, raises and manways – ore chutes extend upward from the drifts to an access level at 2650. Ore mined above at the 2700 level were dumped through the chutes to the haulage adit
- Five major levels occur in the Richmond above the drifts up to the 3000 level – Larger stopes were rectangular and 60 to 150 feet on a side and 60 to 200 feet high with 40 to 80 foot unsupported spans.
- Ore chutes were packed with sulfide muck and clayey waste, others with large rocks suspended in the chute – some with pooled AMD or wet muck at up to 100 degrees

FIGURE 8A PLAN OF HAULAGeways AND STOPES OF THE RICHMOND MINE (COMPILED FROM UNPUBLISHED IMM DATA)

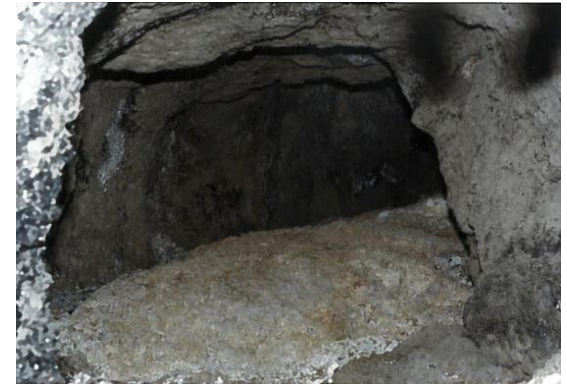
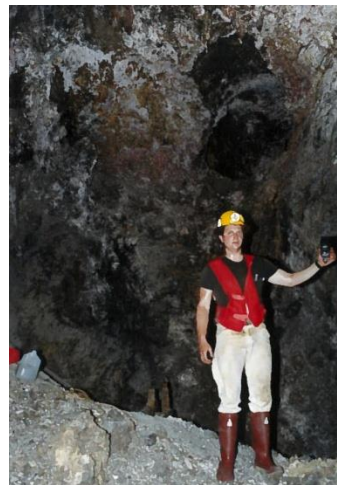
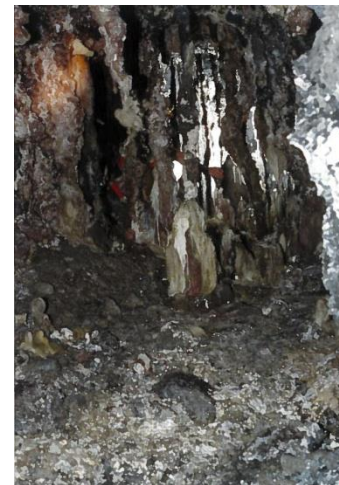
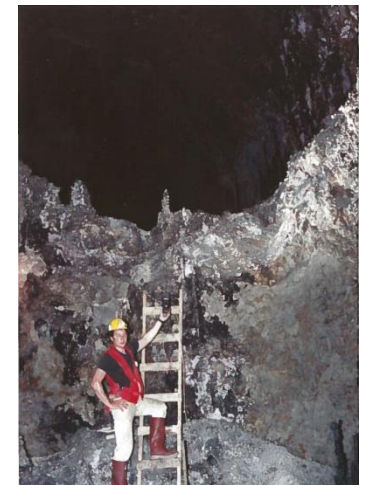
- The 2650 level entered in 1990 and 1991 to evaluate conditions and compare historical mine mapping with actual conditions
- Re-entry encountered extreme heat – greater than 120 degrees due to exothermic reactions of bacterially driven oxidation of massive pyrites
- AMD did not appear to be pooled at the bottom of the stopes except at isolated locations
- AMD pH was measured as low as -3.6 along with abundant crystallization of acid sulfate salts

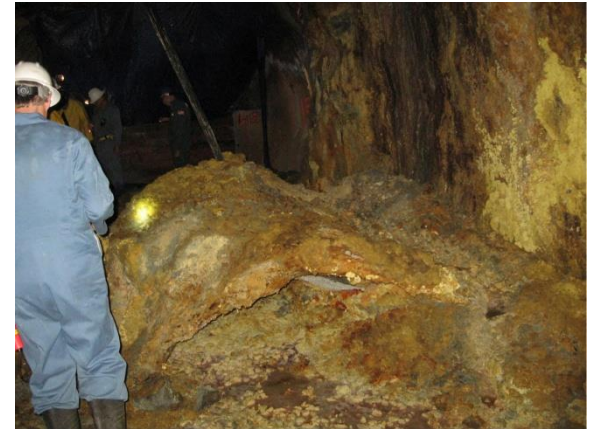
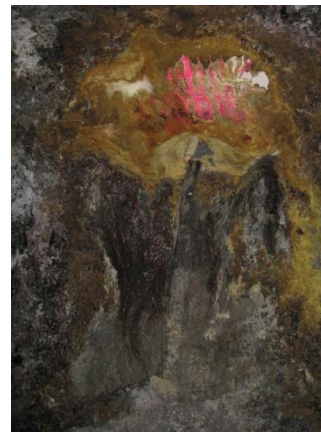
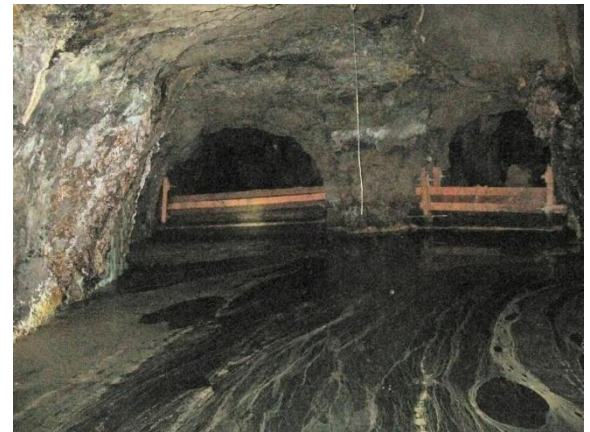
- Inspected annually – usually in the summer to avoid wet winter conditions
- As of the 2013 inspection all ore chutes are considered to be dangerous and to be avoided. Shotcrete on walls and ceilings of drifts is spalling and to be avoided
- A drift has two leaking chute plugs, B drift has seven leaking chute plugs, C drift has nine leaking chute plugs, one of which is leaking at greater than 5 gpm
