The VI Diagnosis Toolkit for Assessing Vapor Intrusion Pathways  
and Impacts in Neighborhoods Overlying Dissolved Chlorinated  
Solvent Plumes

ESTCP Project ER-201501

NOVEMBER 2020

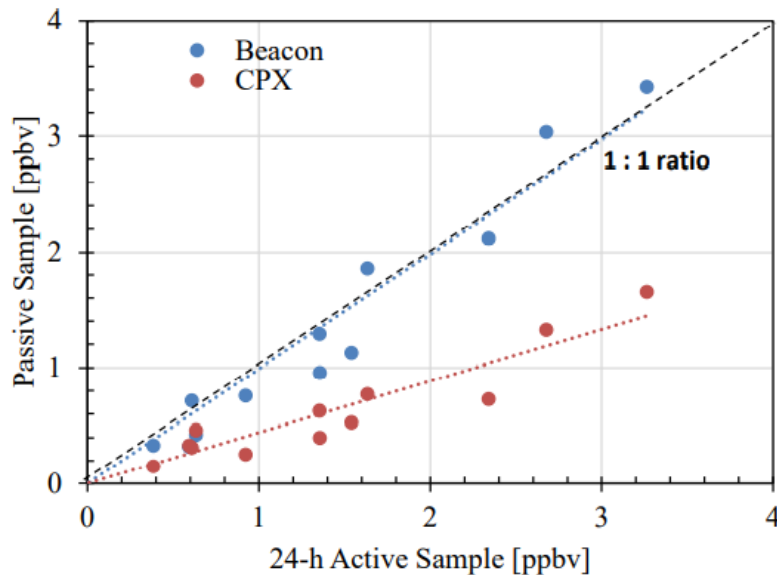
**Figure ES-2. Passive Sampler Results Using Beacon Passive Sampler (Beacon) and Beacon Carbopack X Passive Sampler (CPX) vs Time-averaged 24-h TD Tube Sampling Results for Indoorair TCE Vapor Concentrations.**

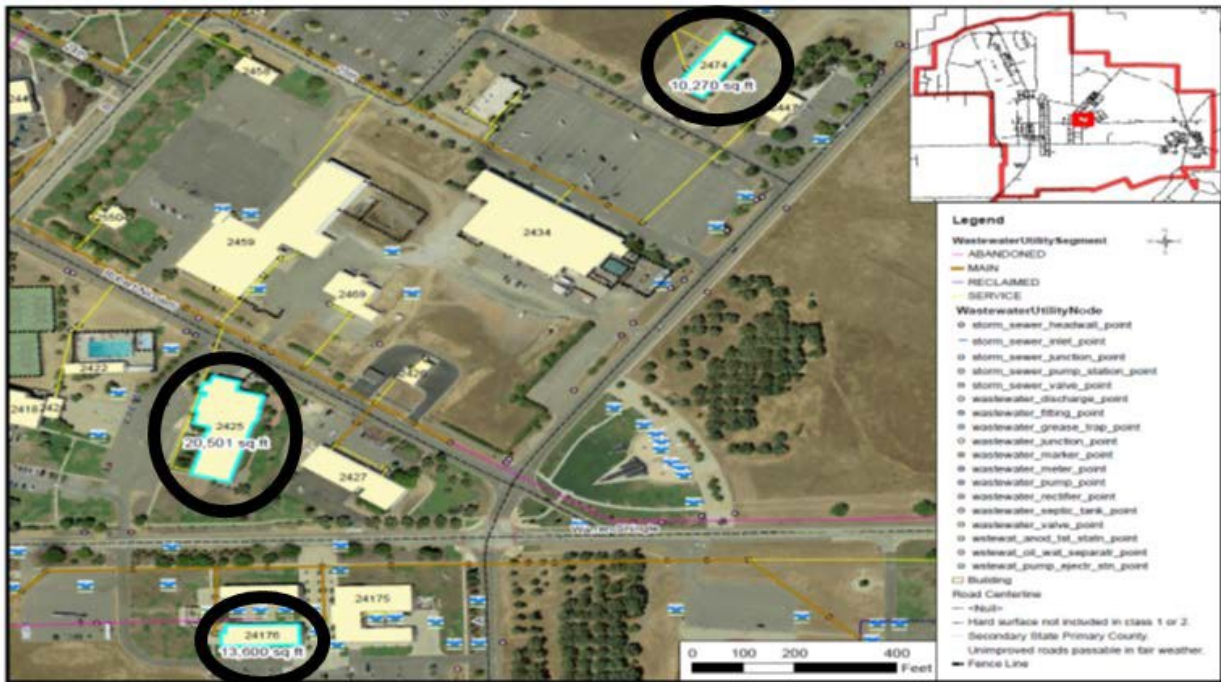
**Figure 4.6. Map for Beale AFB CG041-039 Area, Showing Buildings 2474, 2425, and 24176**

A map of buildings 24176, 2425, and 2474 is shown in Figure 4.6, the attributes of which are shown in Table 4.3.

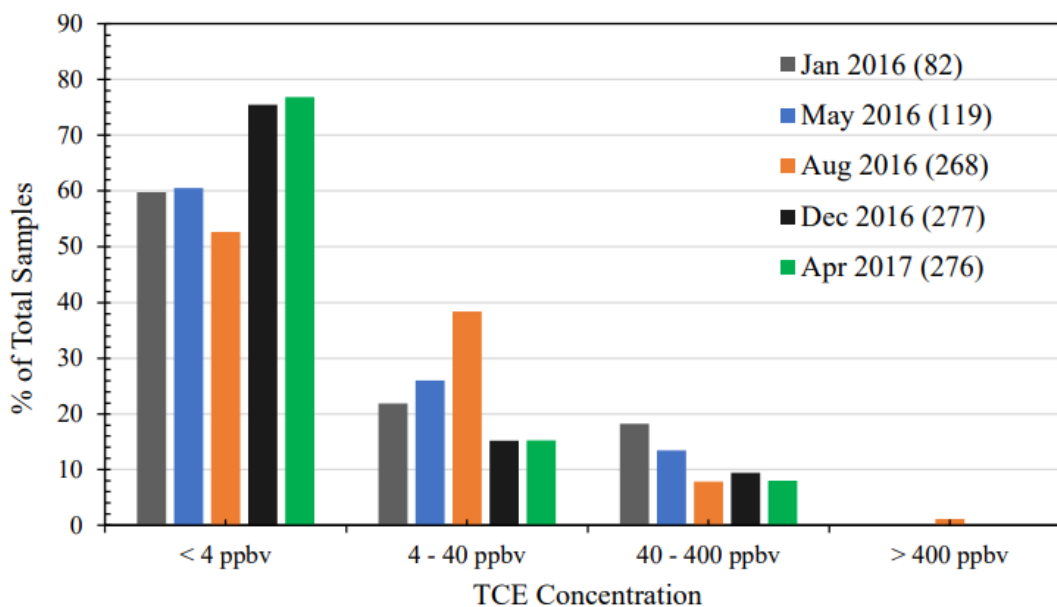
**Figure 6.4. TCE Manhole Vapor Concentration Summary of Five Seasonal Synoptic Sampling Events, Categorized Relative to a 0.4 ppbv Indoor Air Screening Level.**

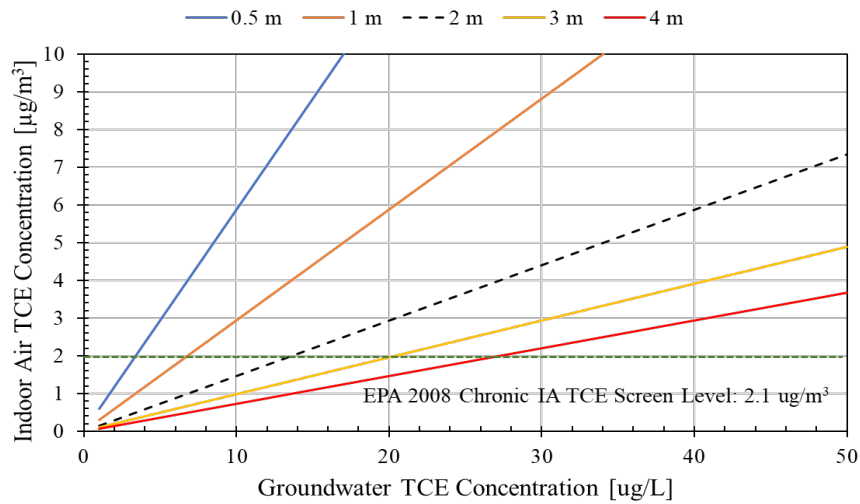
**Figure 6.12. Indoor Air TCE Concentrations Predicted Using Table 6.2 Inputs and a Range of Groundwater Concentrations and Groundwater Depths Representative of the OU-8 Area.**

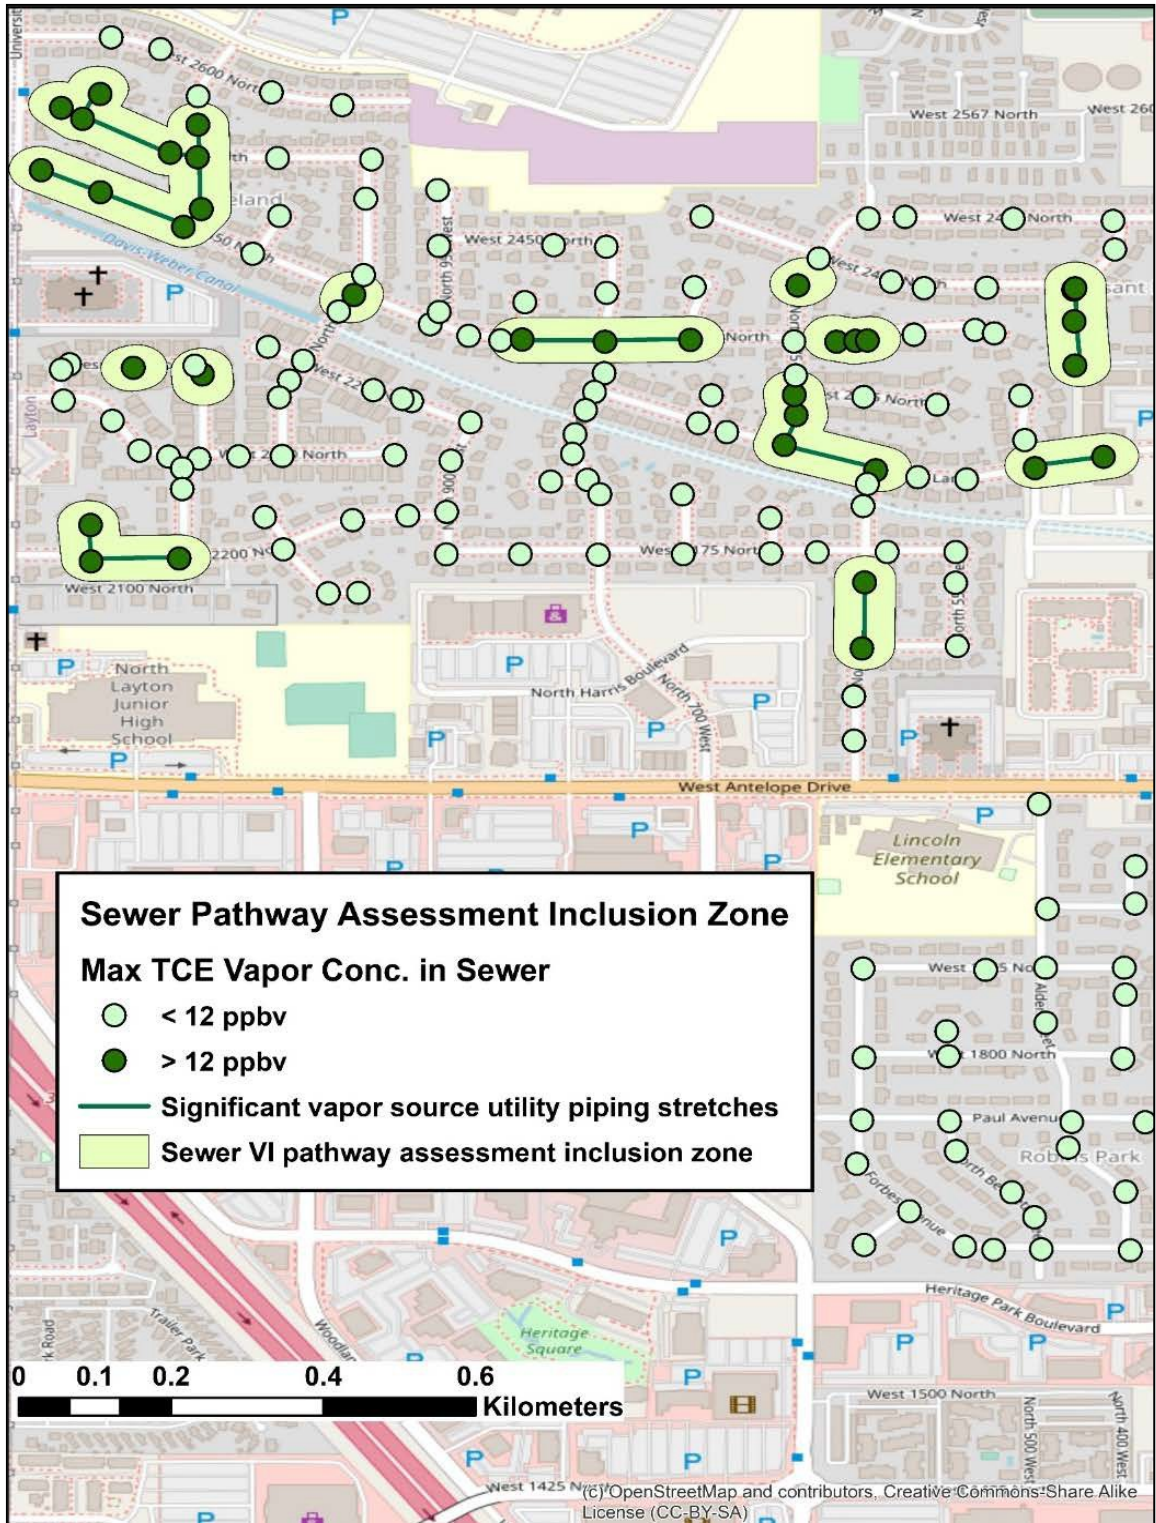
**Figure 6.15. Significant Vapor Source Sewer Manholes and Utility Piping Stretches and Corresponding Sewer VI Pathway Assessment Inclusion Zones.**

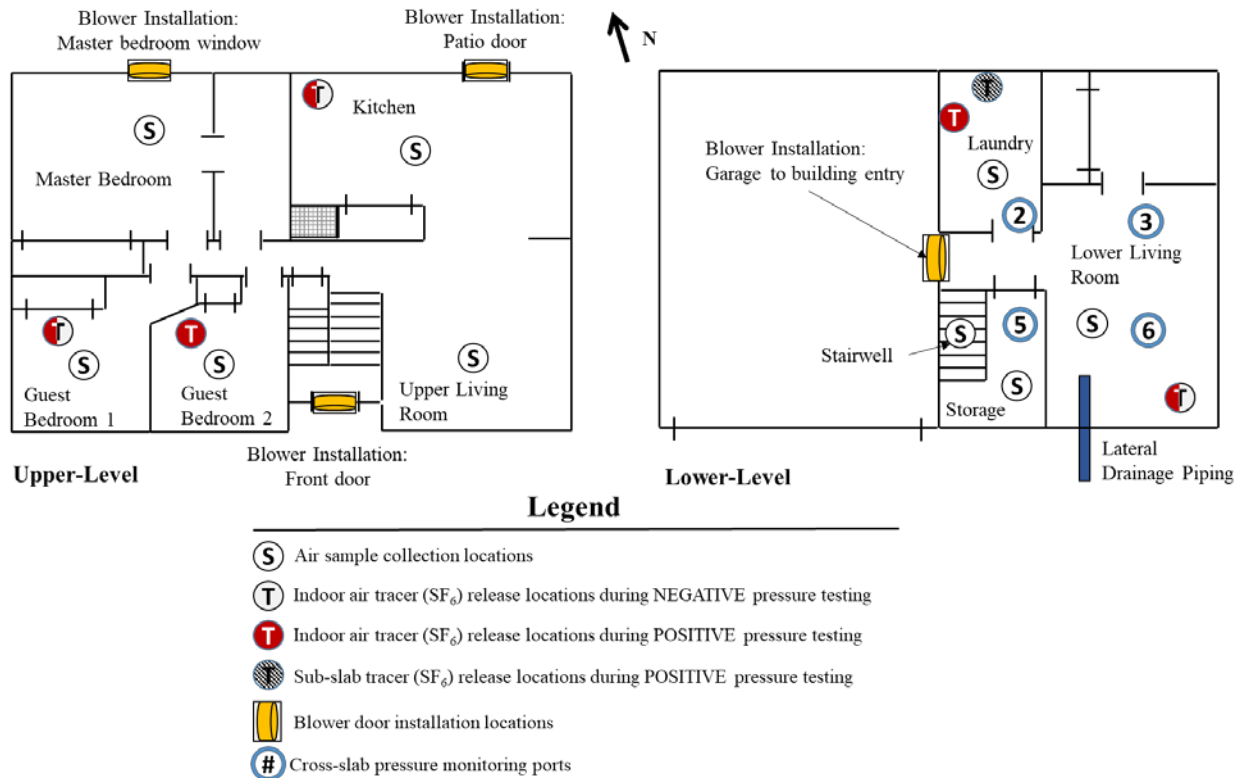
**Figure 6.26. Schematic View of CPM Testing Sampling Locations and Exhaust Fan Placements.**

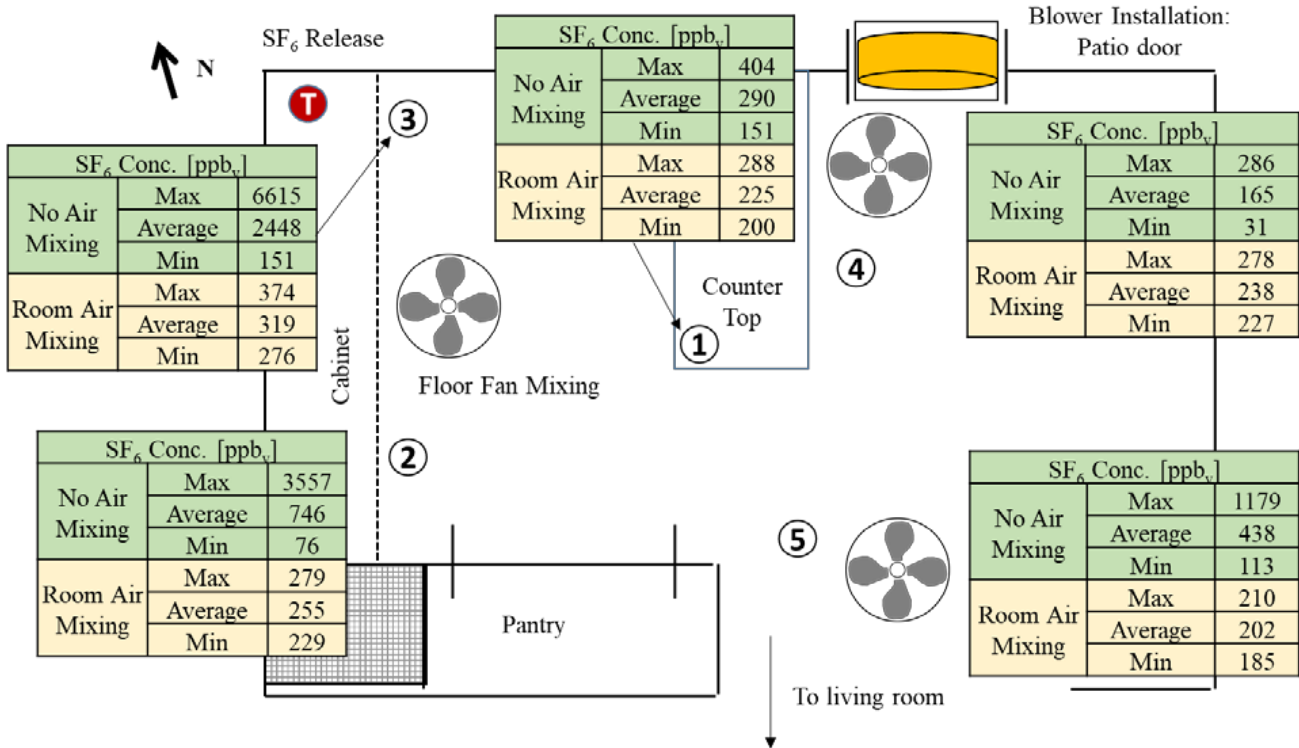
**Figure 6.36. SF<sub>6</sub> Sampling Results in the Kitchen Area During a Positive Pressure Difference CPM Test Having SF<sub>6</sub> tracer Release and Sampling with and Without Active in-Room Air Mixing Using Floor Fans.**

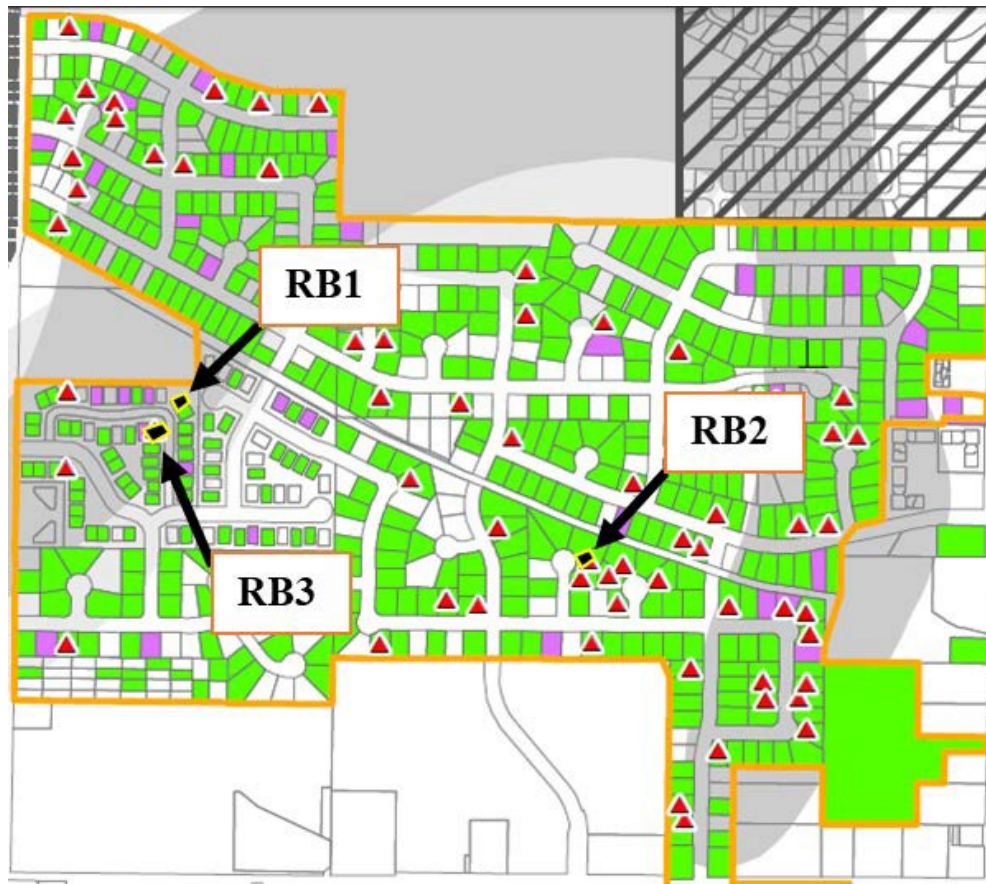
**Figure 6.37. OU-8 Plume and the CPM Demonstration Buildings.**

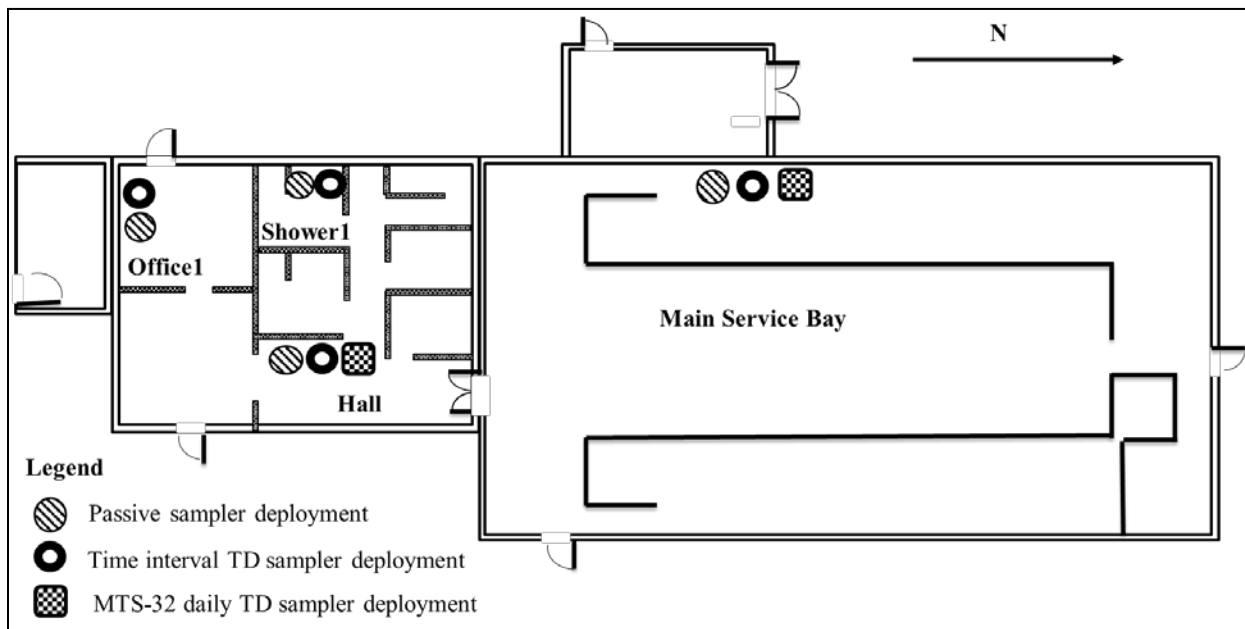
**Figure 6.49. Schematic View of Passive and Active Sampling Plan.**

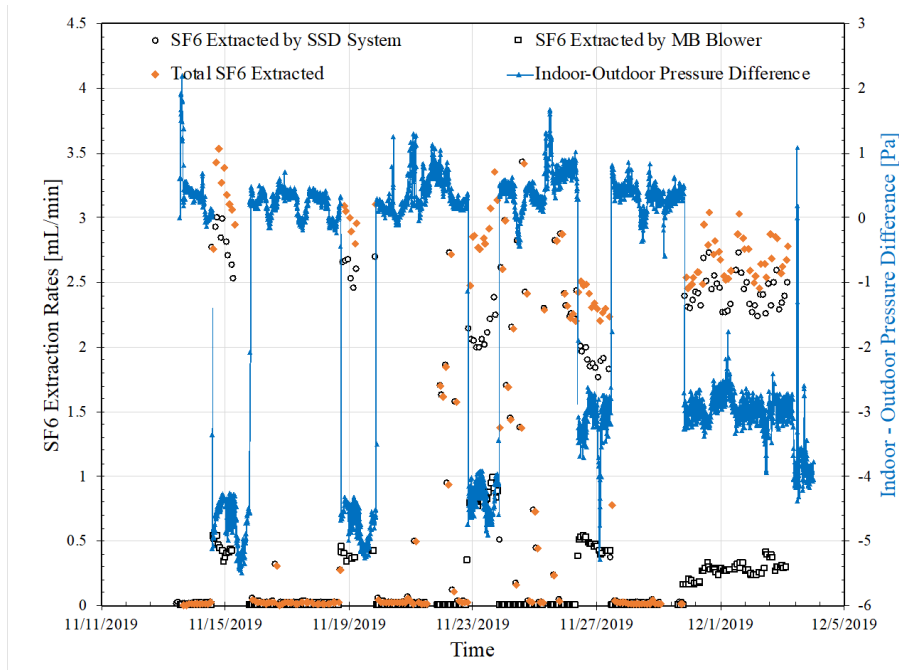
**Figure 6.54. Indoor - Outdoor Pressure Differences and Amounts of SF<sub>6</sub> Extracted by the SSD System and Blower in the House, Expressed as SF<sub>6</sub> Flowrates.**

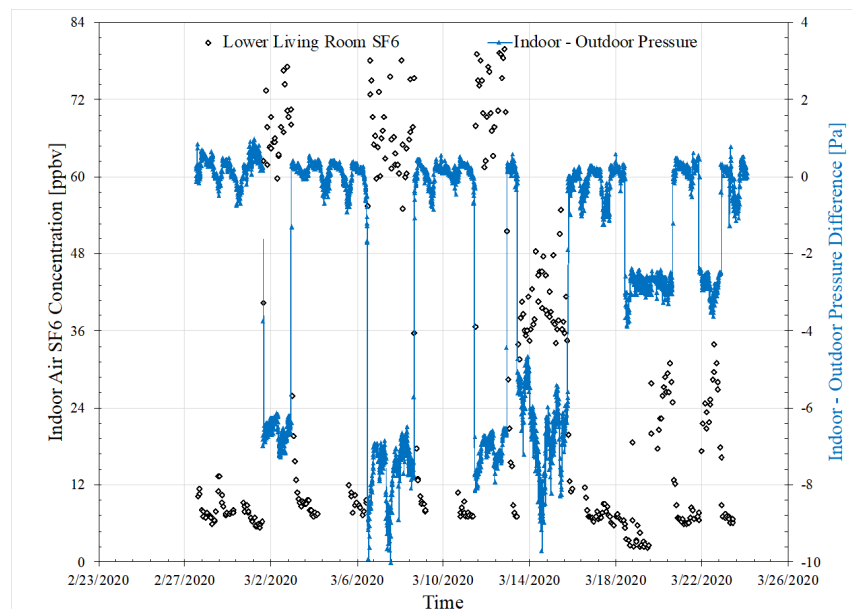
**Figure 6.55. Indoor - Outdoor Pressure Differences and Indoor Air SF<sub>6</sub> Concentrations in the Lower-level Living Room.**

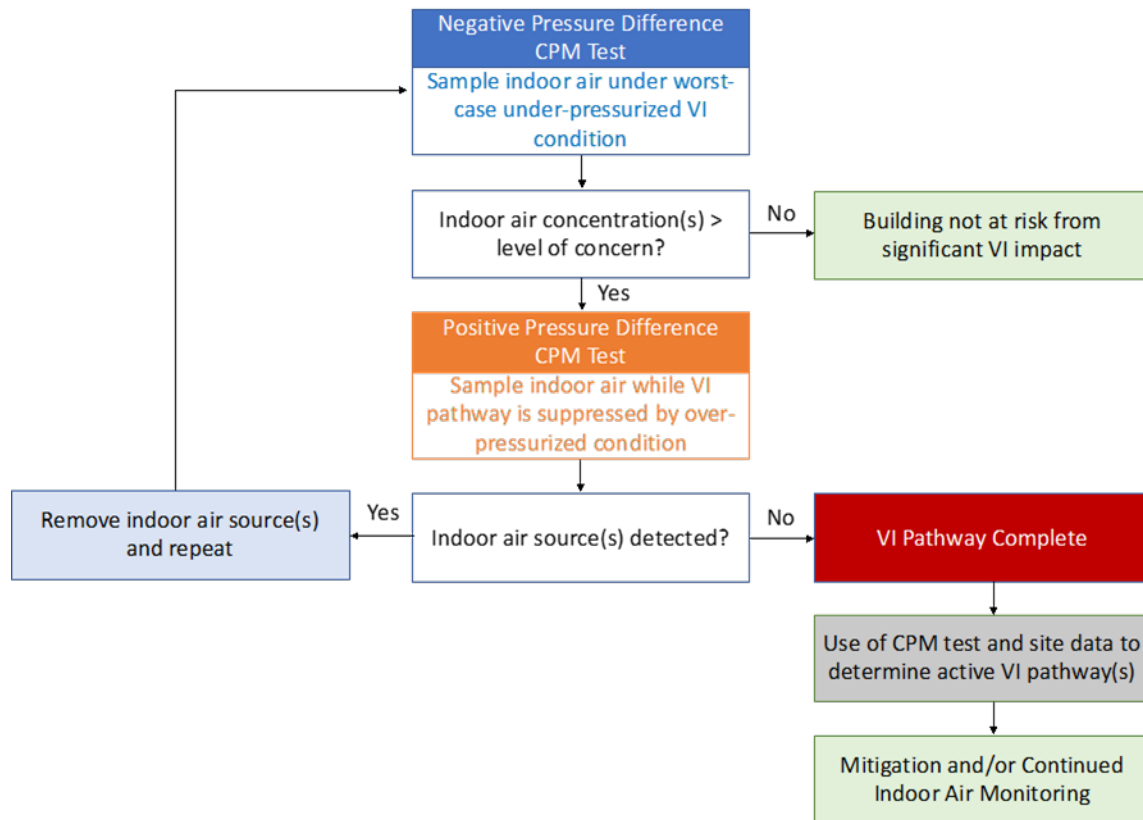
Figure 3. Logic associated with CPM test application and decision-making.

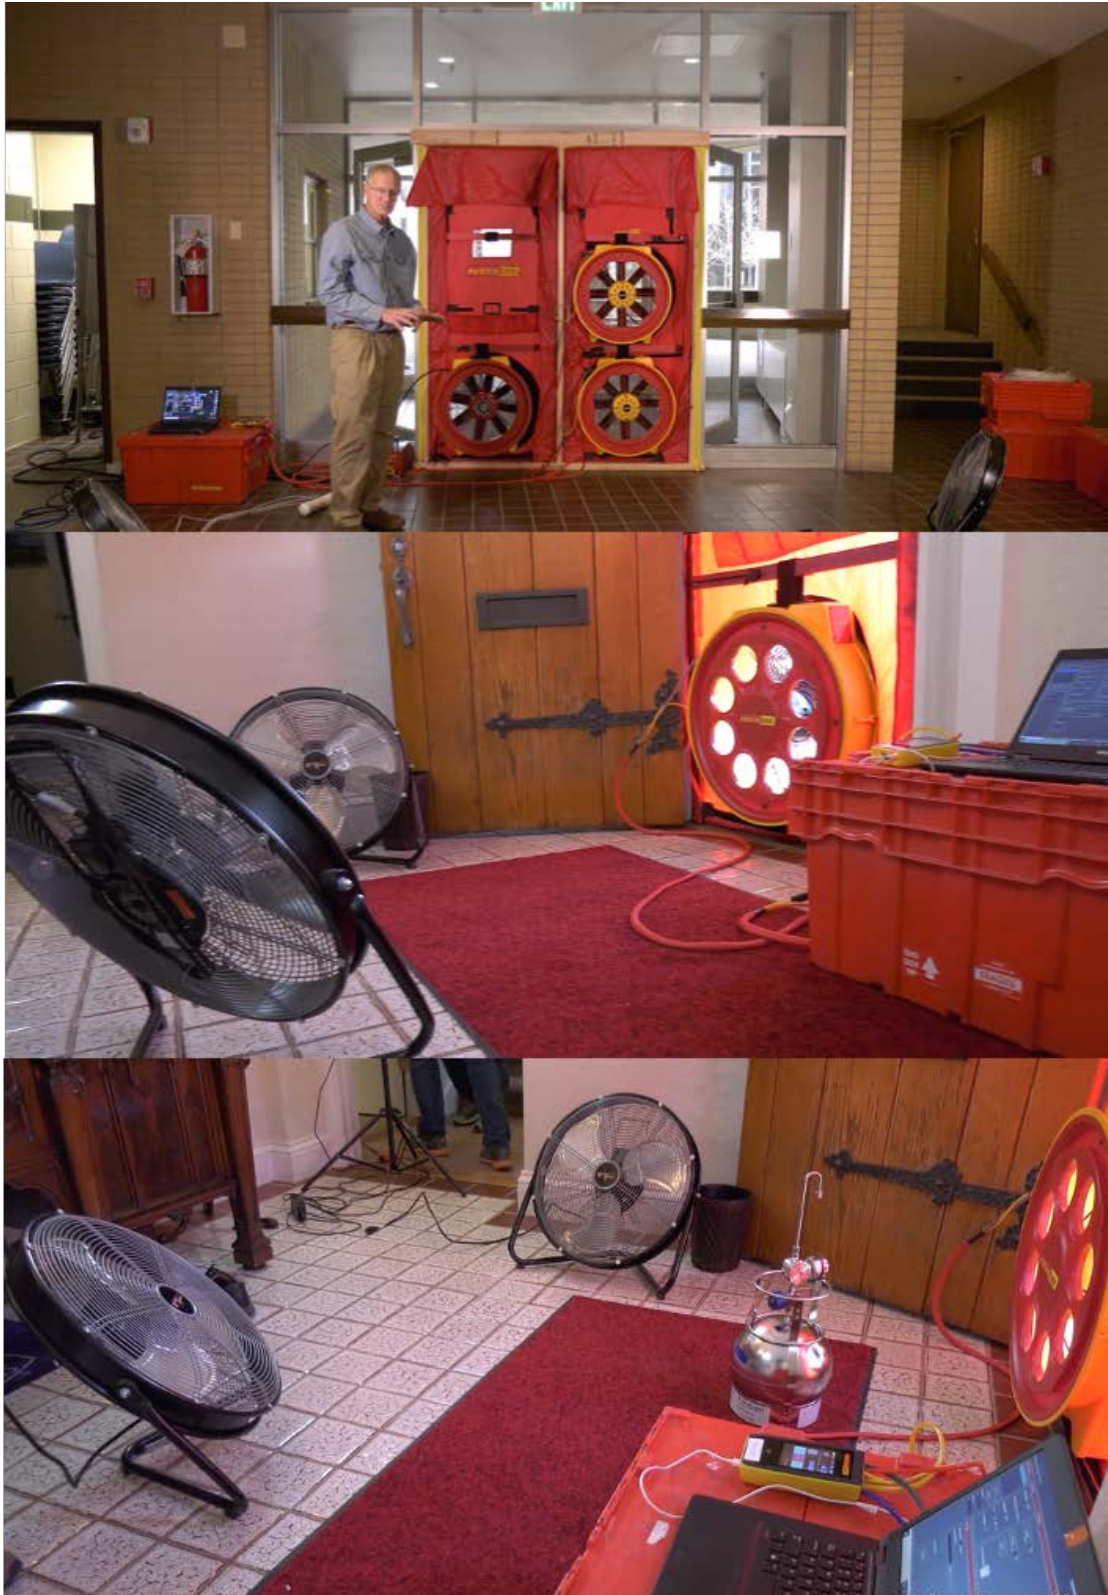
Figure 4. Photos from an industrial multi-blower and residential single blower door CPM test deployment.

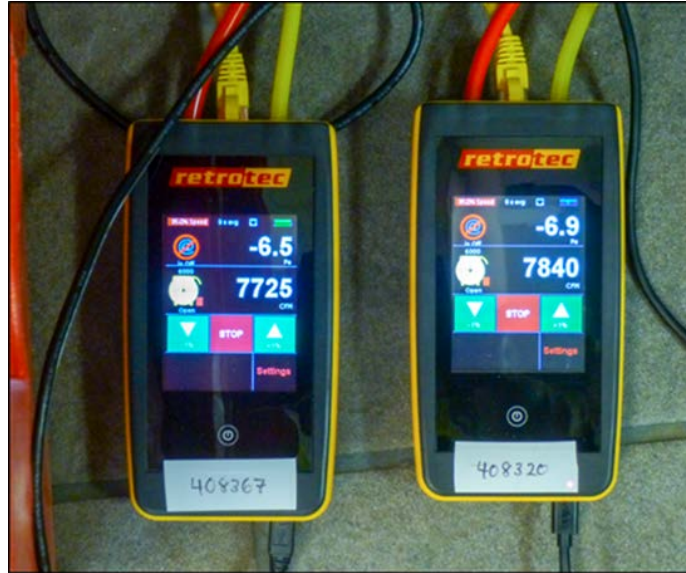
**Figure 2.** Retrotec DM32 controller with display.

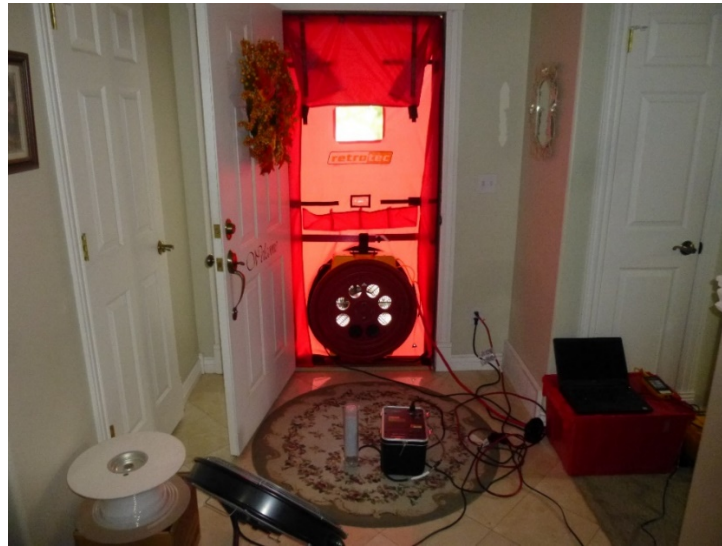
- Adjustable frame with blower door cloth (blower door): The “blower door” included an adjustable frame and cover cloth with a cutout for the blower. The blower door was installed in a man-door doorframe. Figure 3 shows a blower door with a blower in place.

**Figure 3.** Blower door installation and the use of floor fans to facilitate air mixing near the blower intake sampling area.

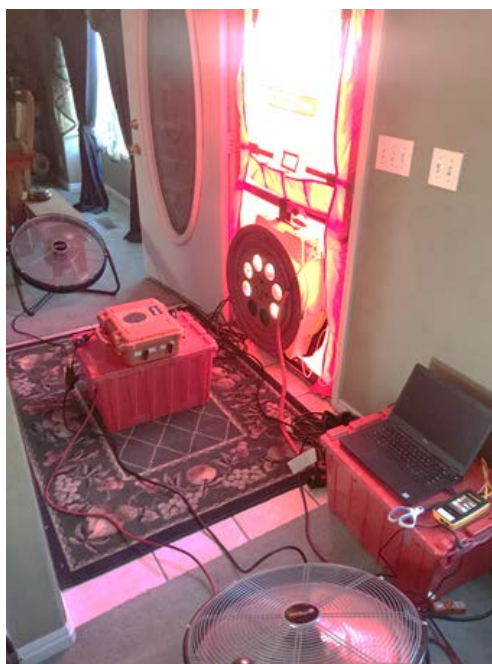
**Figure 3.** Blower door installation and the use of floor fans to facilitate air mixing near the blower intake sampling area.

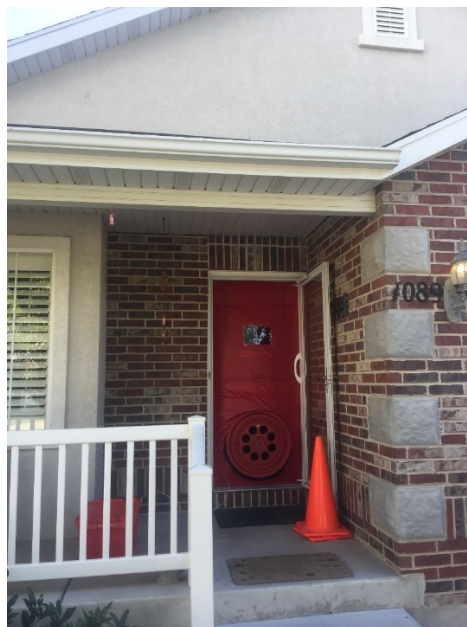
**Figure 3.** Blower door installation.

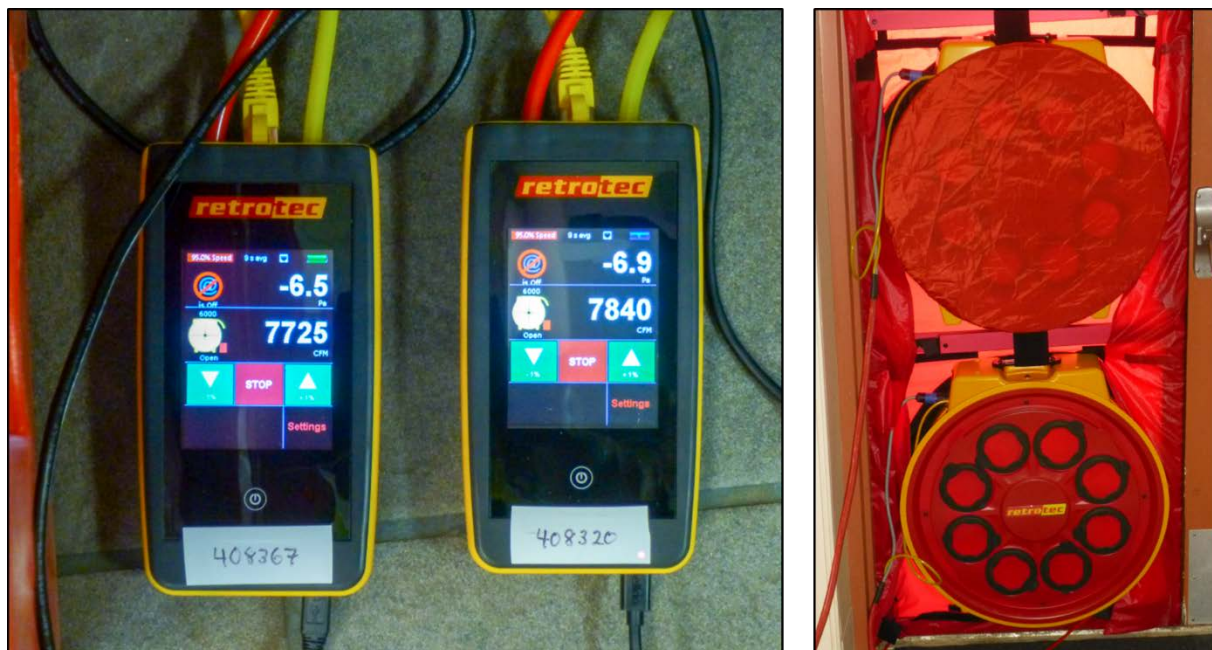
**Figure 2.** Retrotec DM32 with display (left) and blower door with a 2-blower door cloth and blowers (right).

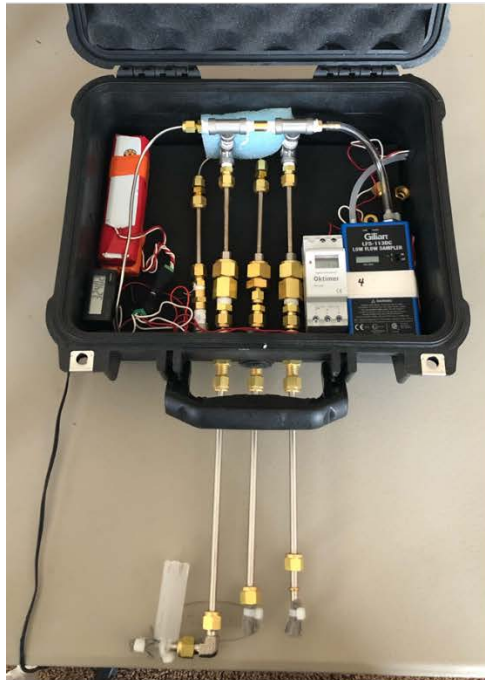
- 18- to 21-day MTS-32 autosampling: 18- to 21-day long-term auto-sampling was also performed using an MTS-32 autosampler (Markes, Ltd., UK). The MTS-32 provided a flowrate controlled service for up to 31 TD tubes. Tubes were deployed sequentially for 24 hours each. Flowrate was controlled at 50 ml/min using a vacuum configured mass flow controller (Alicat Scientific, Tucson, AZ).
- Passive Sampling: **Passive samplers** were deployed for continuous, long-term sampling for a 18 to 21 day period. Passive samplers used were the Beacon Sampler (Beacon Environmental Services, MD) and were sent to Beacon Environmental Services for analysis.

*Long-term, timed interval, active TD tube sampler with passive sampler holder*

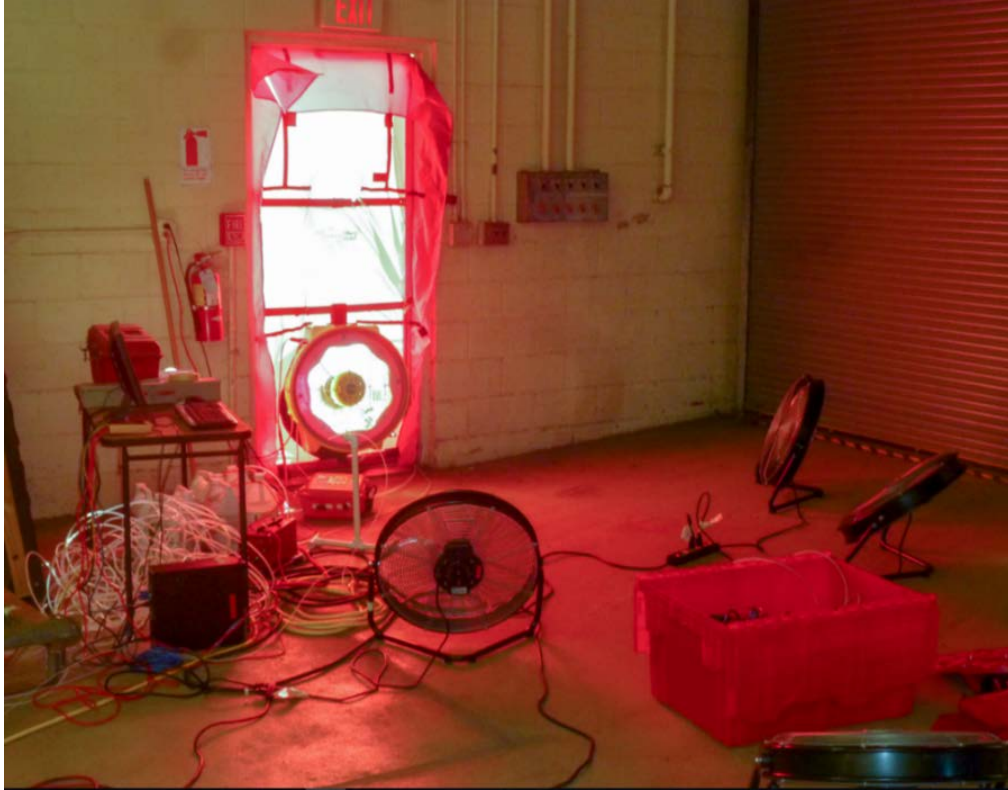
Nine (9) blower intake grab samples were collected throughout negative pressure testing to determine when concentration equilibrium was achieved. Samples were collected at a defined location 1-2 ft from the blower intake as a composite representation of building air quality.

**Figure 4.** The blower door installation and the air mixing near blower intake with floor fans.

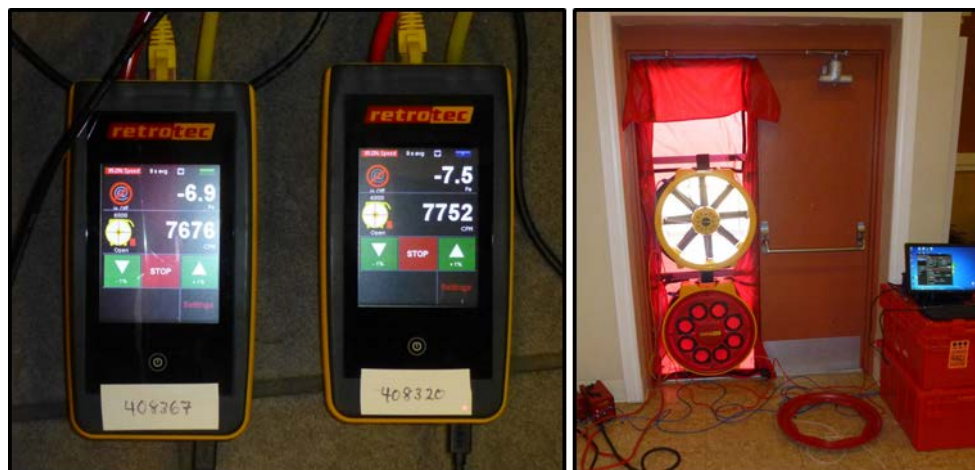
**Figure 5.** Retrotec DM32 with display (left) and blower door with blower (right).

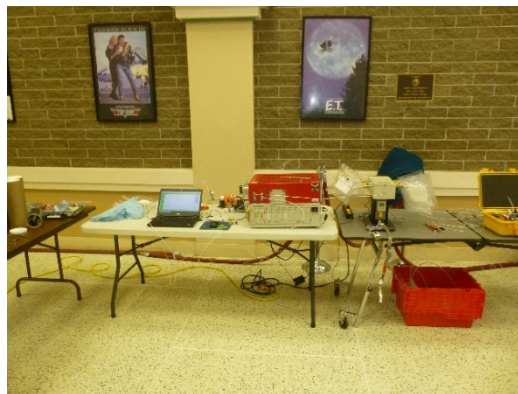
On-site grab sample analyses were performed using an SRI 8610C gas chromatograph (SRI, CA) equipped with a sorbent concentrator and a dry electrolytic conductivity detector (DELCD). The DELCD was well suited for analytical due to its selective nature for only chlorinated and brominated compounds.

The GC-DELCD system was calibrated before negative and positive pressure testing.

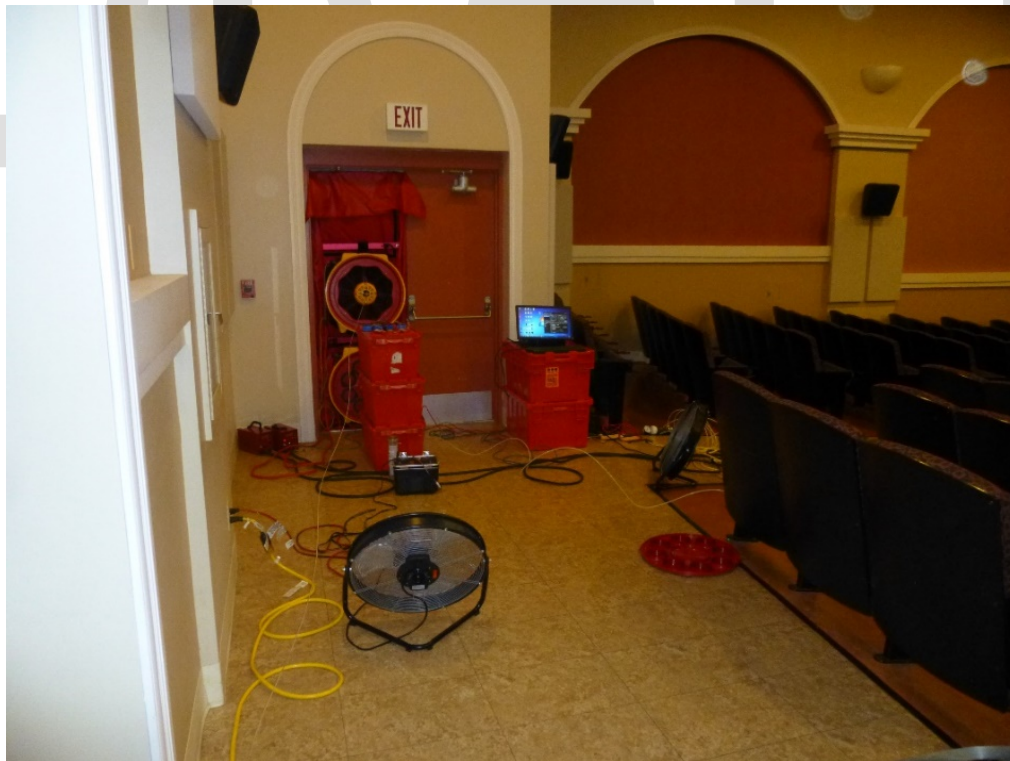
CPM testing was performed over a three-day period as described above; negative pressure test 1 on Oct. 29, positive pressure testing on Oct. 30, and negative pressure test 2 on Nov. 1. For all tests, the blower-door/blower was installed in the man-door along the northwestern wall of the building at the back of the theatre auditorium. Figures 7 and 8 show the blower installation location and installation, respectively.

**Figure 8.** Blower door installation and the use of floor fans to facilitate air mixing near the blower intake sampling area.

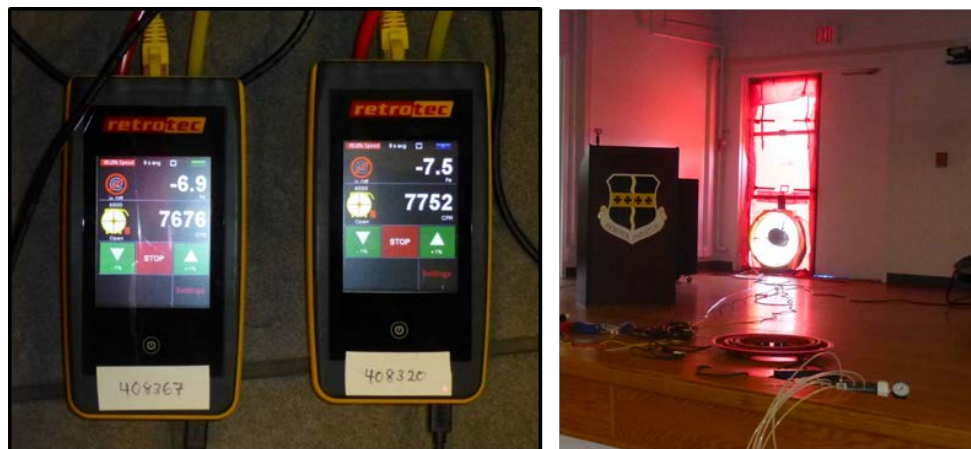
**Figure 5.** Retrotec DM32 with display (left) and blower door with blower (right).

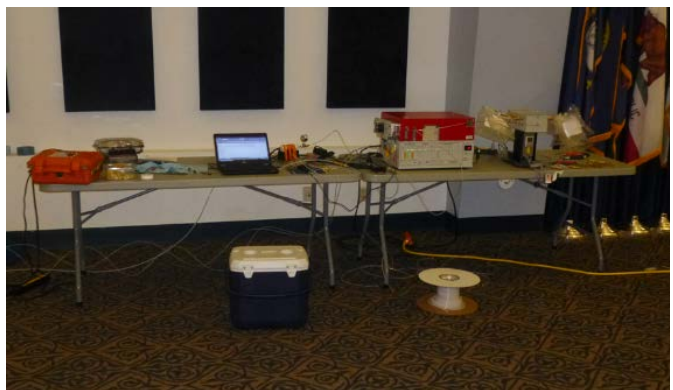
On-site grab sample analyses were performed using an SRI 8610C gas chromatograph (SRI, CA) equipped with a sorbent concentrator and a dry electrolytic conductivity detector (DELCD). The DELCD was well suited for analytical due to its selective nature for only chlorinated and brominated compounds.

The GC-DELCD system was calibrated before negative and positive pressure testing. Calibration concentrations ranged from 0.01 to 10 ppb<sub>v</sub> for both negative and positive pressure testing. Calibration standards were prepared by dilution in clean Tedlar bags using Zero-air and a custom chlorinated compound calibration gas stock (Scotty Analyzed Gases).

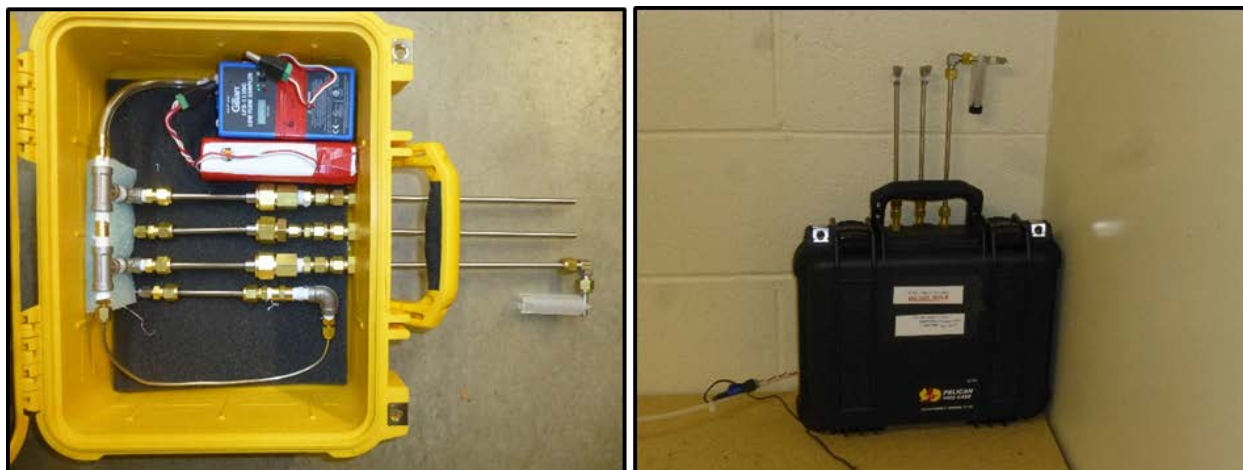
- 18-day, timed interval sampling: 18-day, timed interval sample collection used a single Sensidyne Gilian LFS-113 pump in constant pressure mode to provide a continuous pressure source to a manifold with restrictor orifices to control flowrates for multiple tubes. The active sampling time was timer controlled to reduce collection volume to prevent TD tube sorbent saturation if indoor air concentrations were high. Active sampling was performed for 10-minute intervals every 1.5 hours throughout the sampling period, a total of 160 minutes per day. See Figure 6 for sampler photo.

**Figure 6.** Active TD tube and Passive sampler deployment with passive sampler, TD tube active samplers in triplicate with a single tube for breakthrough assessment, pump, and timer.

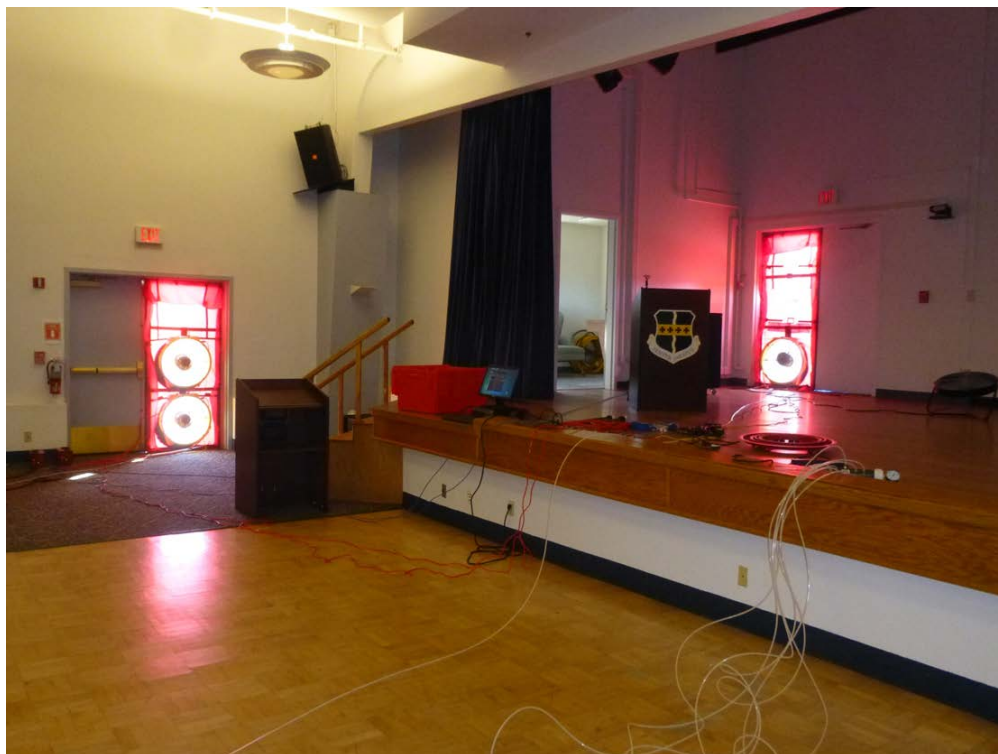
CPM testing was performed over a two-day period as described above; negative pressure testing on Oct. 27 and positive pressure testing on Oct. 28. For each test, the blower-doors/blowers were installed in two (2) exit doorways, the stage exit which held a single blower configuration, and the exit in the southeast corner of the auditorium, which held a two blower configuration. Figure 7 shows a map view of the blower installation locations. Figure 8 shows the blower installations in which the single and double blower configurations are visible.

**Figure 8.** Blower door installation and the use of floor fans to facilitate air mixing near the blower intake sampling area.
