# **Assessment and Restoration of the BP Llandarcy Refinery Landfill**

**Martin Chapple, URS Corporation Ltd., Bristol, UK**

**25th May 2004**

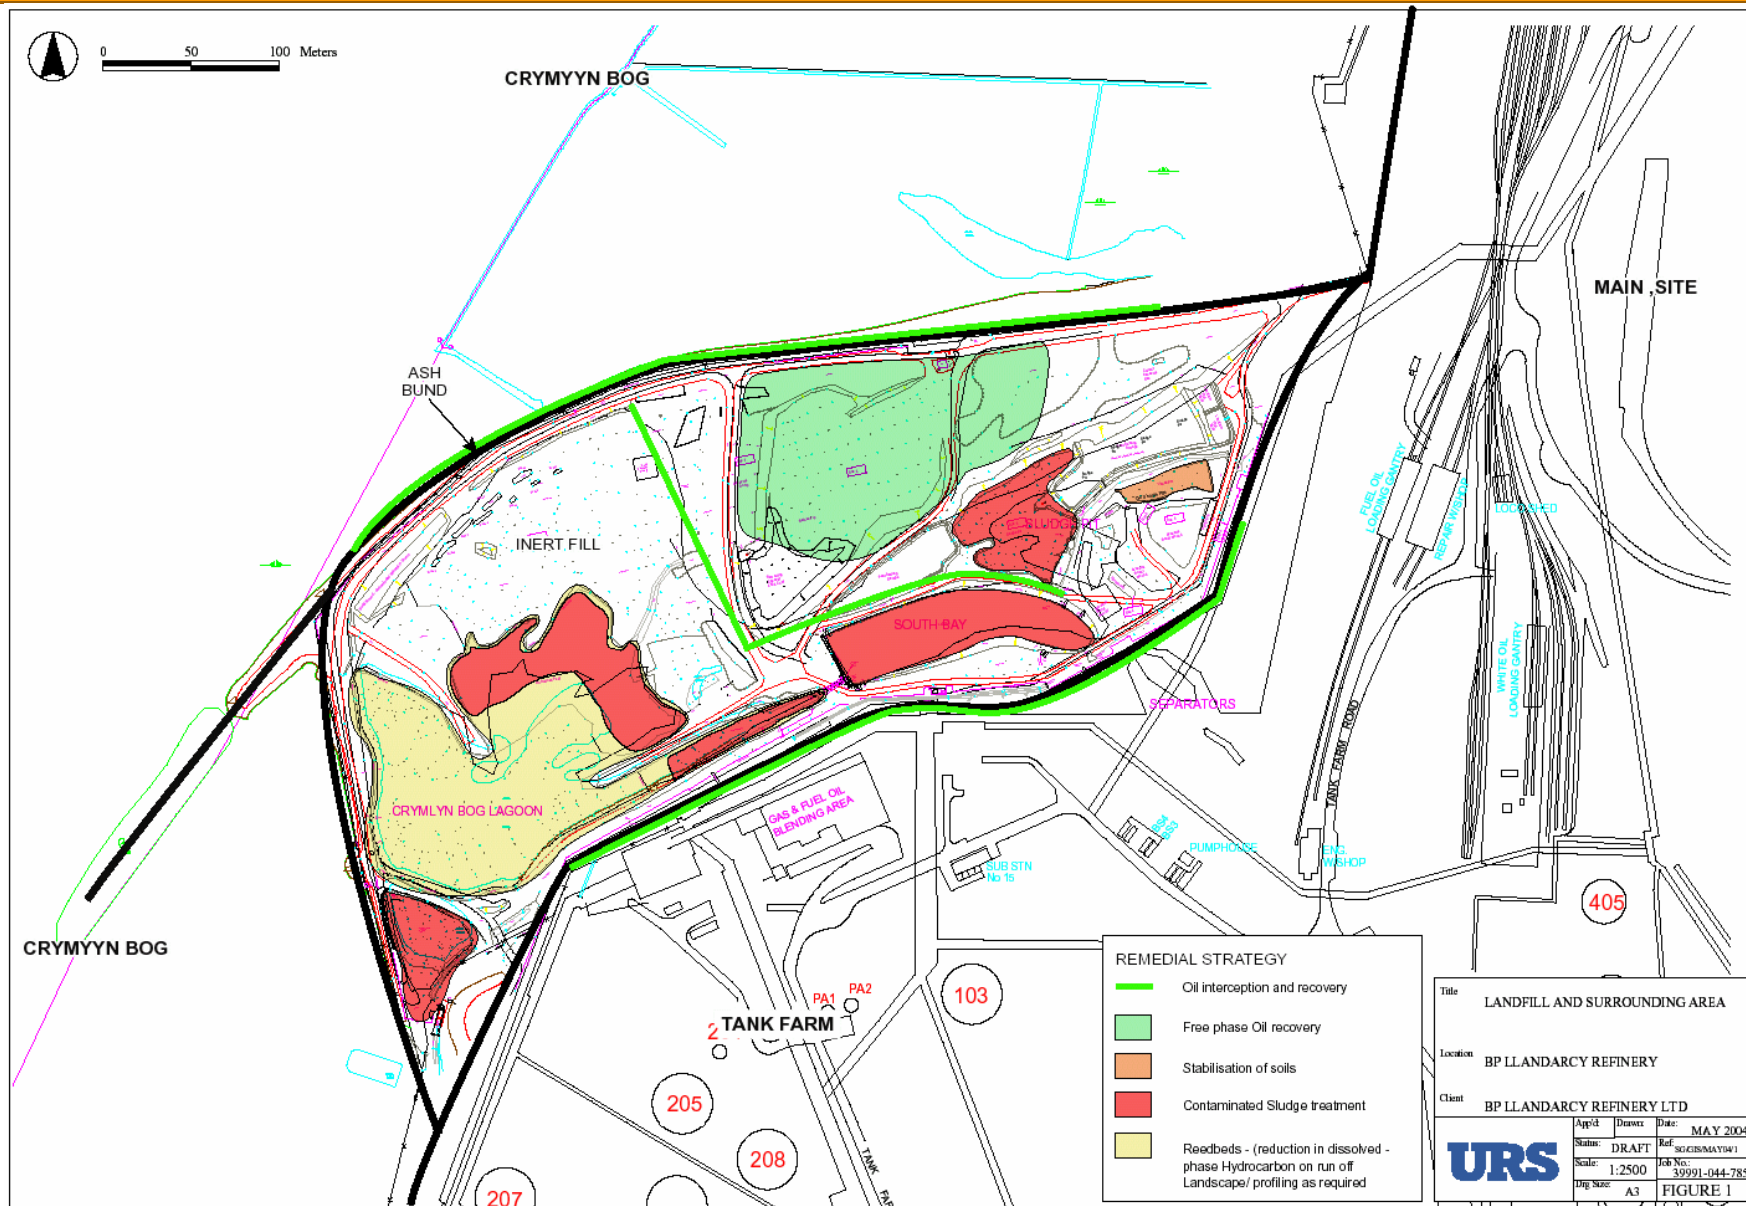
# Conceptual Remedial Approach

- Protect open water areas from free oil discharge
  - Isolate Tip area from Main site
  - Intercept oil entering existing separation lagoon from landfill
  - Intercept oil migrating outward to Crymlyn bog
  - Recover free-phase oil from landfilled area
- Sludge/Waste Treatment
  - Excavate and treat tank-bottom sludge pit
  - Treat contaminated materials from separation lagoons
  - Stabilise vanadium lagoon
- Dissolved-Phase Hydrocarbon Flux Control
  - Encourage/construct reedbeds as sustainable and attractive way to reduce dissolved hydrocarbon in runoff; pilot tests completed in 2003
- Amenity Development
  - Landscaping, to improve aspect of area, but also including permeable cap to maintain hydraulic gradients and promote mobility of remaining free-phase oil
