**Plume Delineation Using
Membrane Interface Probe (MIP)
Savannah River Site
Aiken, South Carolina**

Westinghouse Savannah River Company, LLC
P.O. Box 6809
Aiken, South Carolina 29804-6809

COLUMBIA Technologies, LLC
1450 South Rolling Rd.
Baltimore, Maryland 21227
410-536-9911

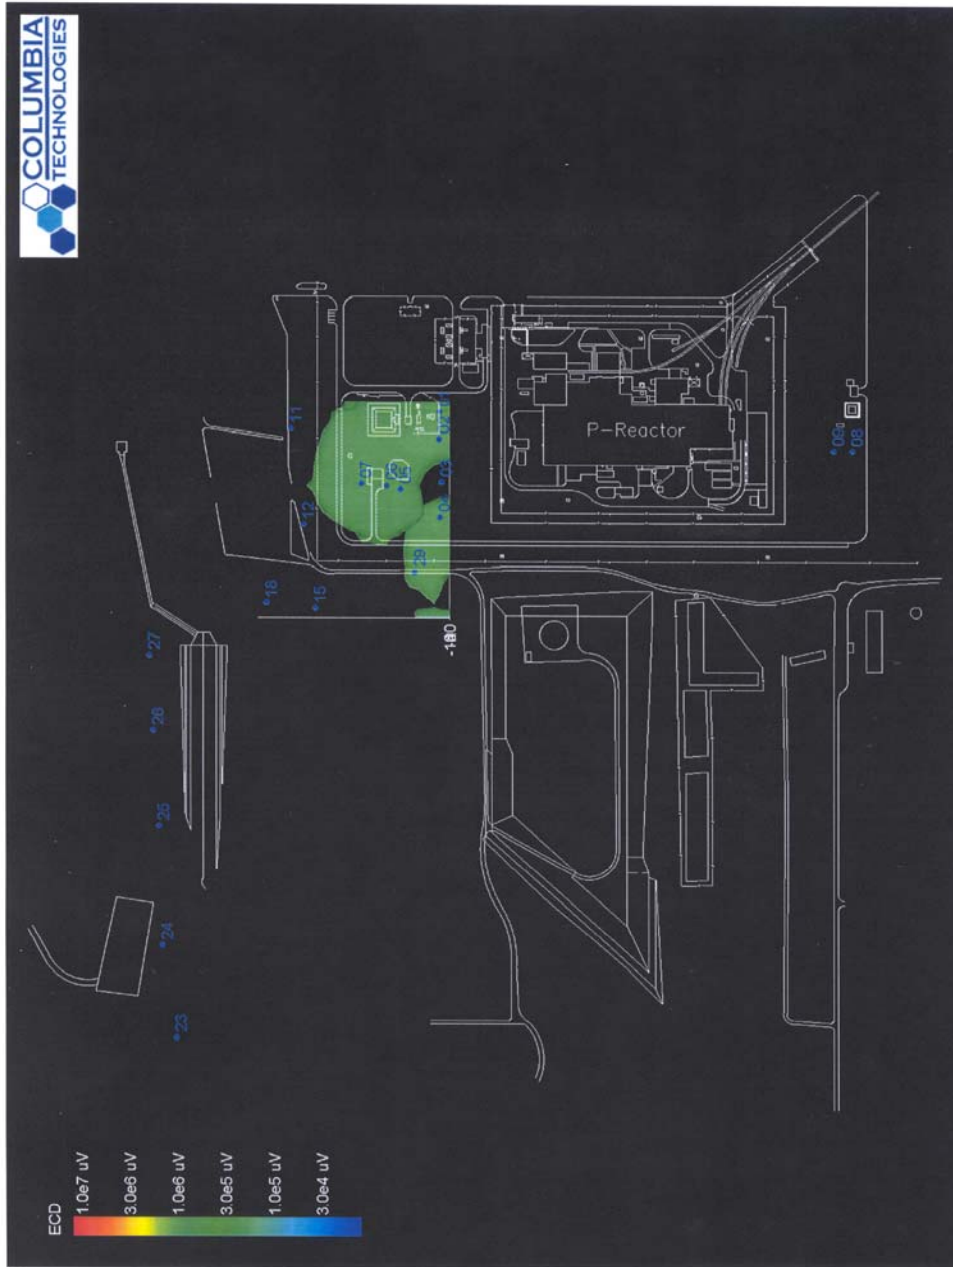
Figure 2
ECD Response, 1.0E+06uV and Above,
Plan View of the Entire Site
Westinghouse Savannah River Company, LLC
Savannah River Site
September 18th, 2002 – October 4th, 2002

The ECD responded significantly at a number of locations at this site, which indicate the presence of chlorinated compounds at depth (Figures 2, 3 and 4). The ECD is very sensitive to chlorinated compounds. At high concentrations, the detector becomes saturated at the value of $1.2E+07$ microvolts (uV). This occurred at several locations. When this occurs, the PID can be used to determine relative contamination concentration, as it also responds to chlorinated compounds. Saturation of the ECD occurred at locations PGCPT-01, PGCPT-02, PGCPT-04, PGCPT-07, and PGCPT-09. The PID response at these locations measured $2.0E+05$ uV, $3.0E+05$ uV, $1.25E+06$ uV, $1.25E+06$ uV, and $5.0E+05$ uV, respectively, thus the highest levels of contamination detected by the MIP at the site occurred at locations PGCPT-04 and PGCPT-07.

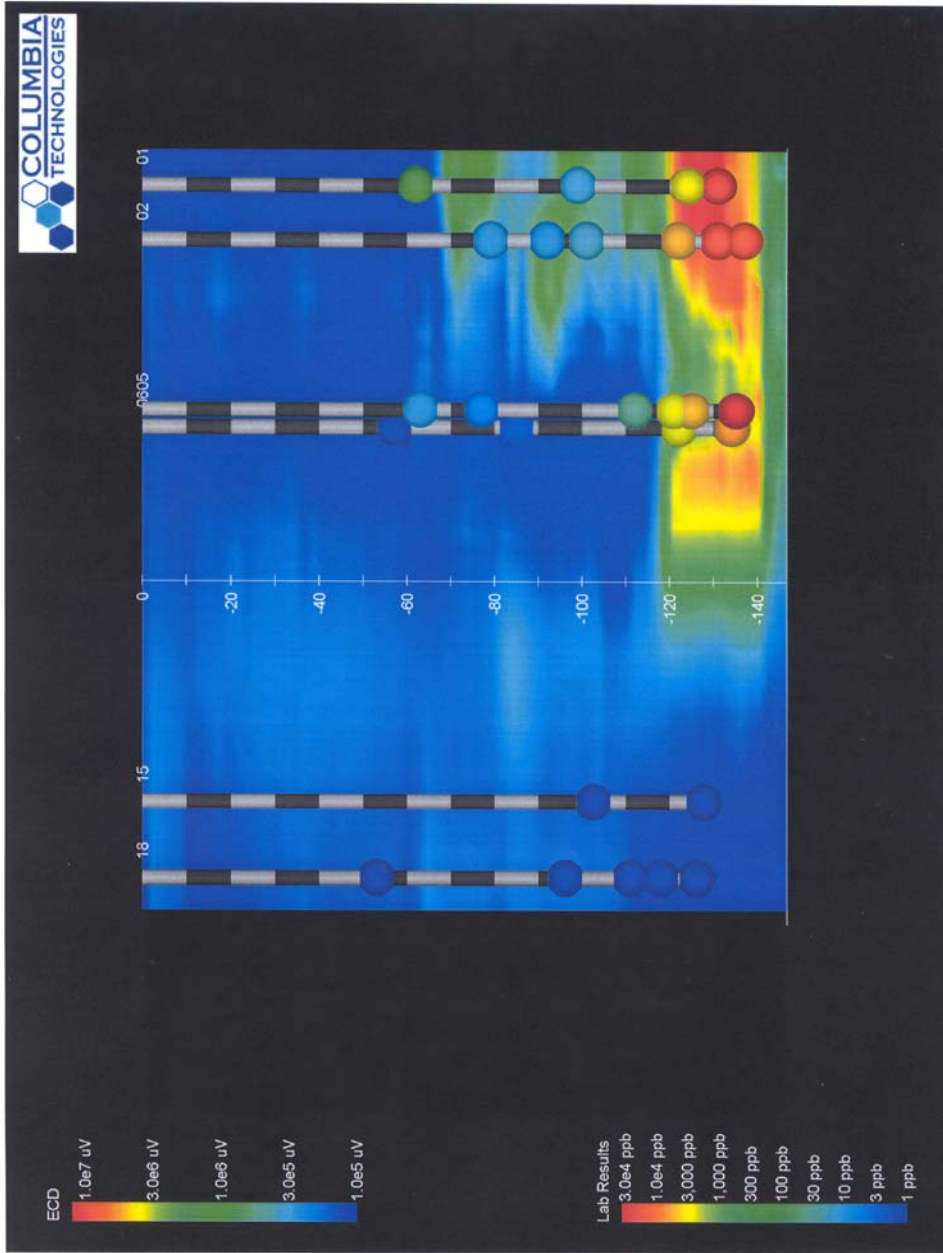
Figure 7
ECD Response, Northwest to Southeast Cut
With Laboratory Results
Westinghouse Savannah River Company, LLC
Savannah River Site
September 18th, 2002 – October 4th, 2002

also shows the areas where the MIP did not detect any chlorinated compounds. This conclusion is confirmed with numerous blue spheres that indicate non-detect water samples taken from these areas. One orange sphere does lie between two zones of higher concentration, as defined by the MIP system, and will be discussed below in the paragraph on false negatives. Figure 7 is a transect connecting the profiles from PGCPT-18, in the northwest corner of the site, to PGCPT-01, in the southeast corner of the site (see Figure 1 for transect location). This illustration also clearly shows the high correlation between water sample laboratory data and MIP detection.
