SMWG REVIEW AND ANALYSIS OF SELECTED SEDIMENT DREDGING PROJECTS (REVISED)

Presented at:
The 2nd Meeting of the
National Research Council Committee on Dredging
Effectiveness at Superfund Megasites
June 7, 2006
Irvine, California

SITES TO BE REVIEWED

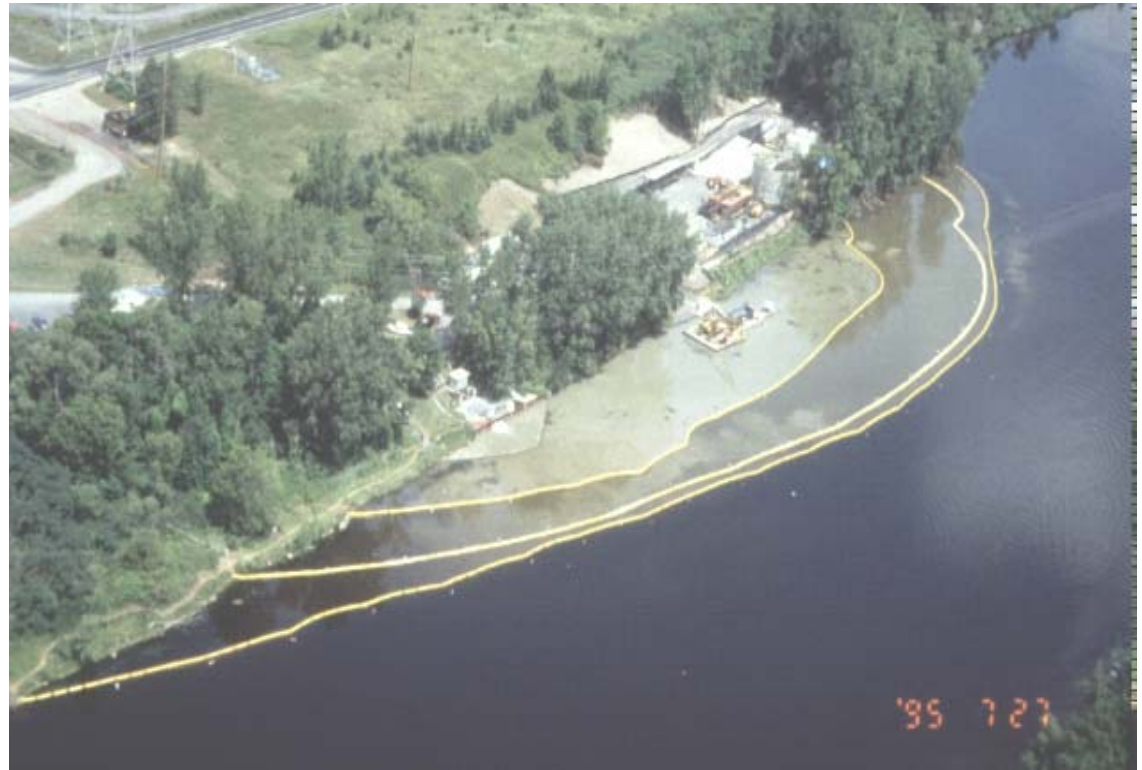
- 3,000 cy sediment and debris with PCBs removed in 1995 (Alcoa)
- Mechanical debris removal and hydraulic dredging (horizontal auger)
- Sediment dewatered and disposed on site
- Goal: Removal of “all” sediment
- Heavily studied/monitored program
- Performed as NTCRA
- Project cost = \$4.9 million (\$1670/cy)

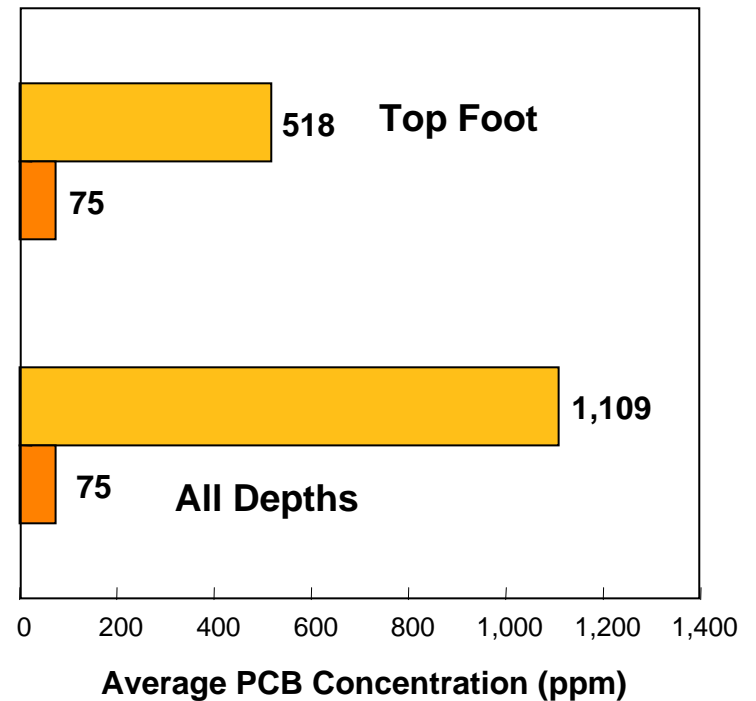
Average Sediment PCB Concentrations

Pre-NTCRA (1991, 1993) Post-NTCRA (1995)

- Pre-dredge prism: 1,108 mg/kg
- Pre-dredge average surficial: 518 mg/kg
- Post-dredge average surficial: 75 mg/kg

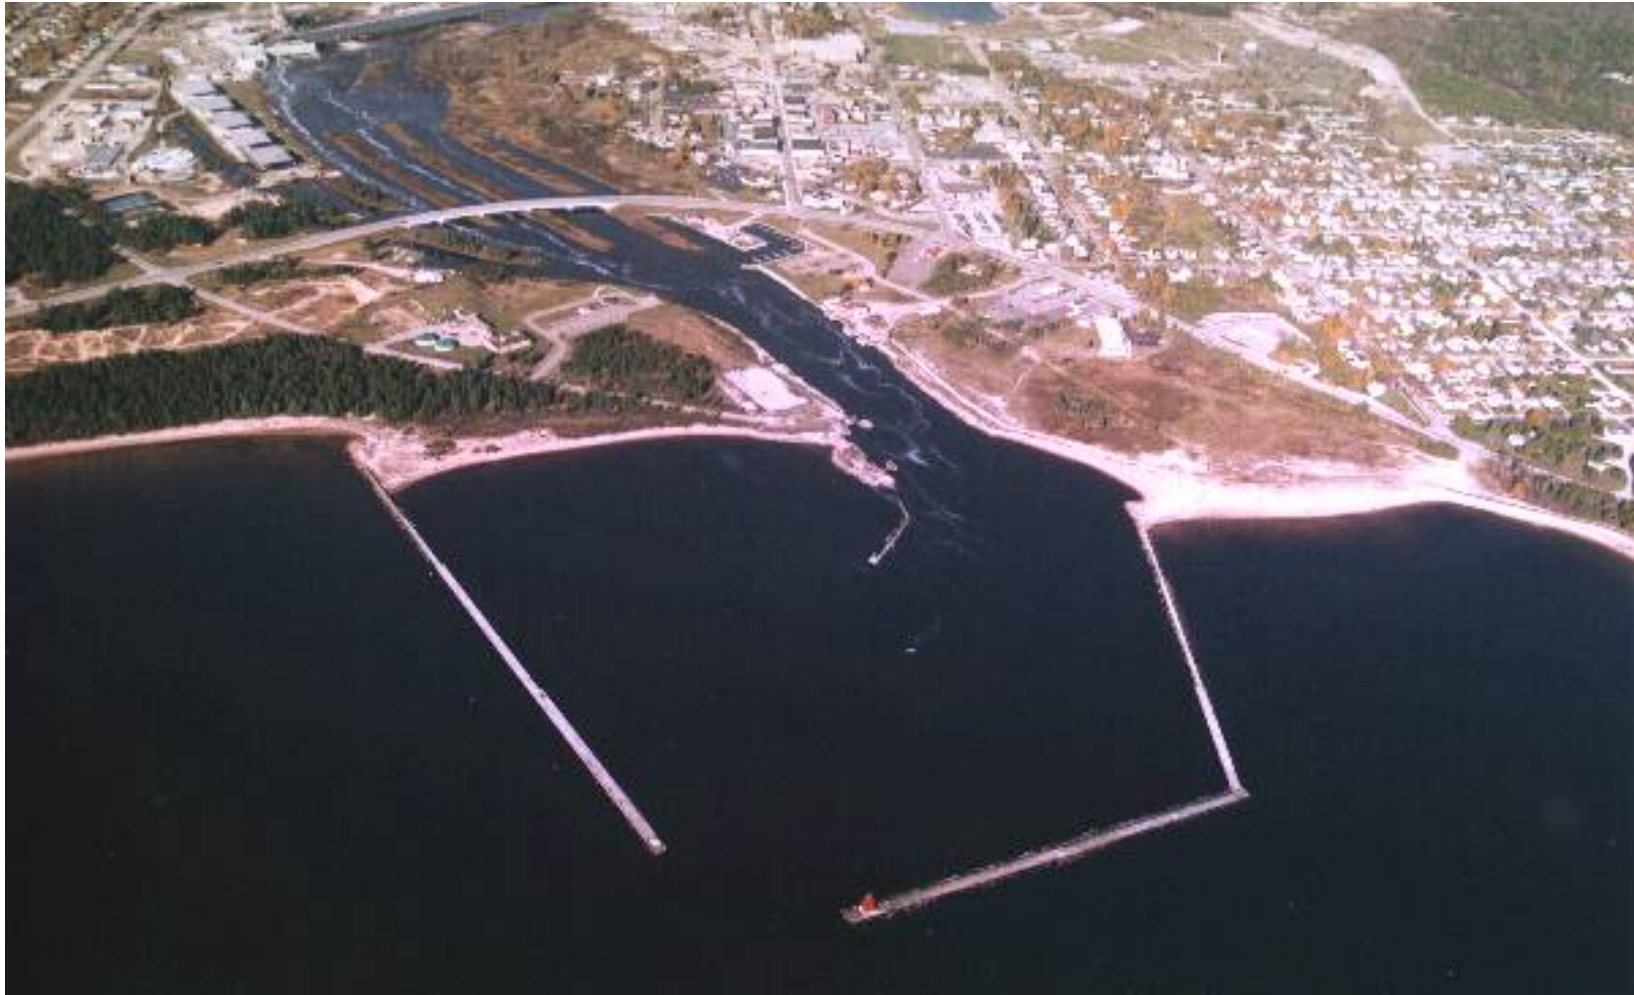
MANISTIQUE RIVER & HARBOR, MANISTIQUE, MI

- Site Background/Remedy Description:
 - River and Harbor Areas - 64 acres
 - River reach - 1.7 miles
 - Approximately 15 acres dredged
 - Dredging 1995 - 2000 (6 years)
 - Hydraulic dredging and substantial diver- assisted hand dredging

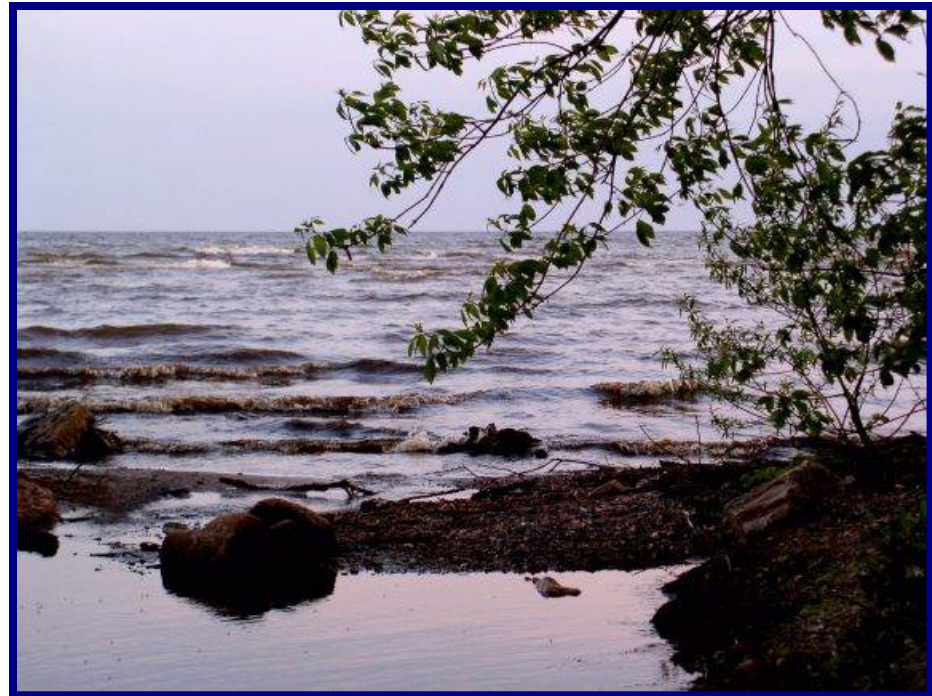
FOX RIVER, WI

- Deposit 56/57
(1999-2000)
- Deposit N
(1998-1999)

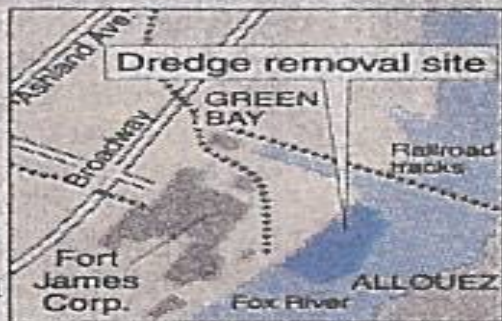
..... Hot spot area

- - - Dredging area

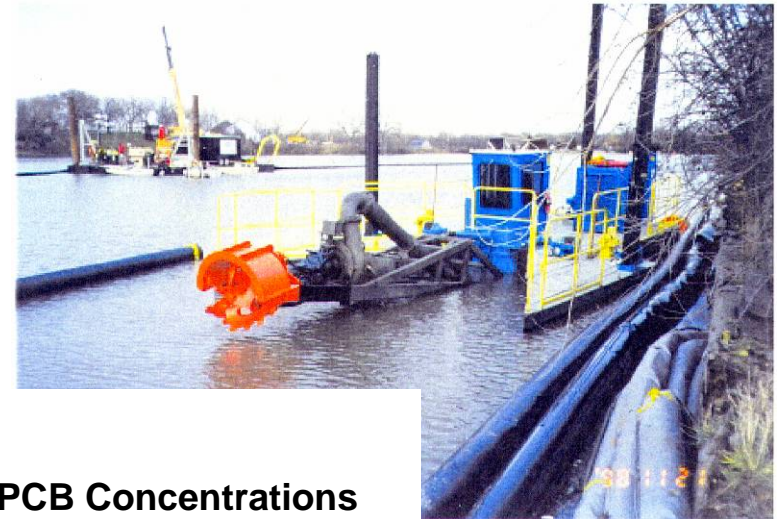
FOX RIVER, WI: Deposit N - West Lobe

- Pre-dredge average surficial = 11 ppm; post-dredge 14 ppm (Foth), 21 ppm (BB&L)
- Fractured bedrock prevented overdredging and led to difficulties with residuals
- Dredging removed 78% mass, but resulted in post-dredge surface concentrations similar to pre-dredge levels
- Roughly 8% of the PCB mass targeted for removal remained as residuals

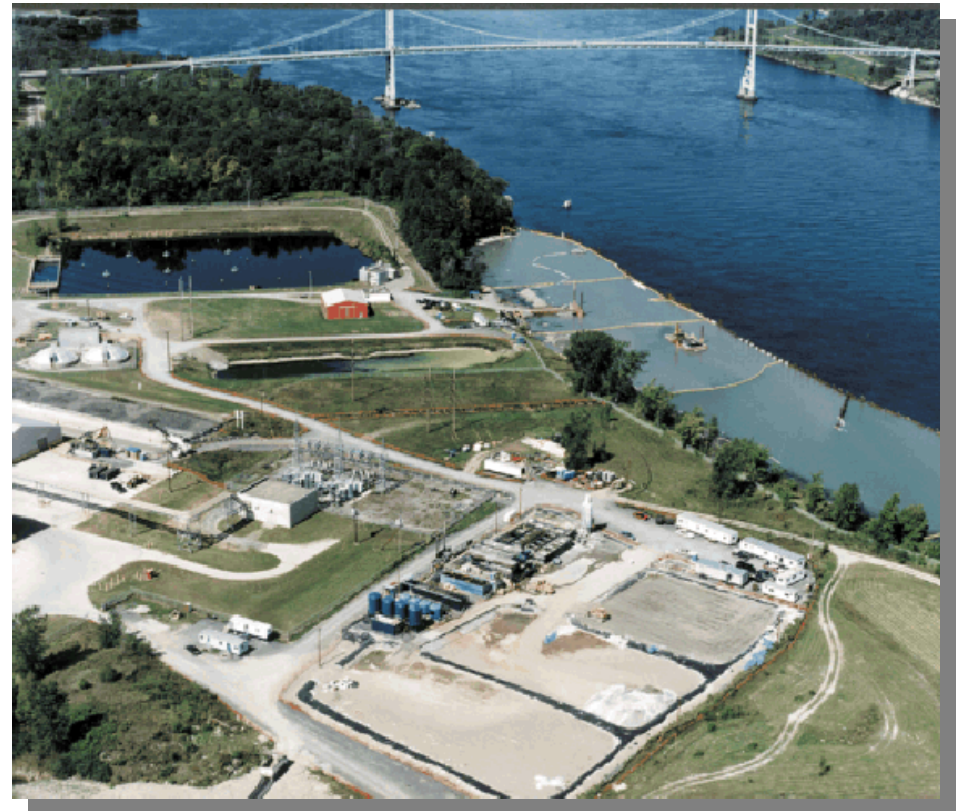
- 11-acre area of nearshore sediments dredged in 1995
- Goal 1 ppm PCB (sediment)
- Mechanical debris removal and hydraulic dredging (horizontal auger)
- Projected cost = \$11.5 million (\$870/cy)
- 1 ppm cleanup goal unachievable (up to 30 passes)
- Average surficial PCBs >9.2 ppm
- One area capped after removal
- Silt containment—steel sheeting

1 ppm PCB cleanup goal for sediment was unachievable, even with significant effort

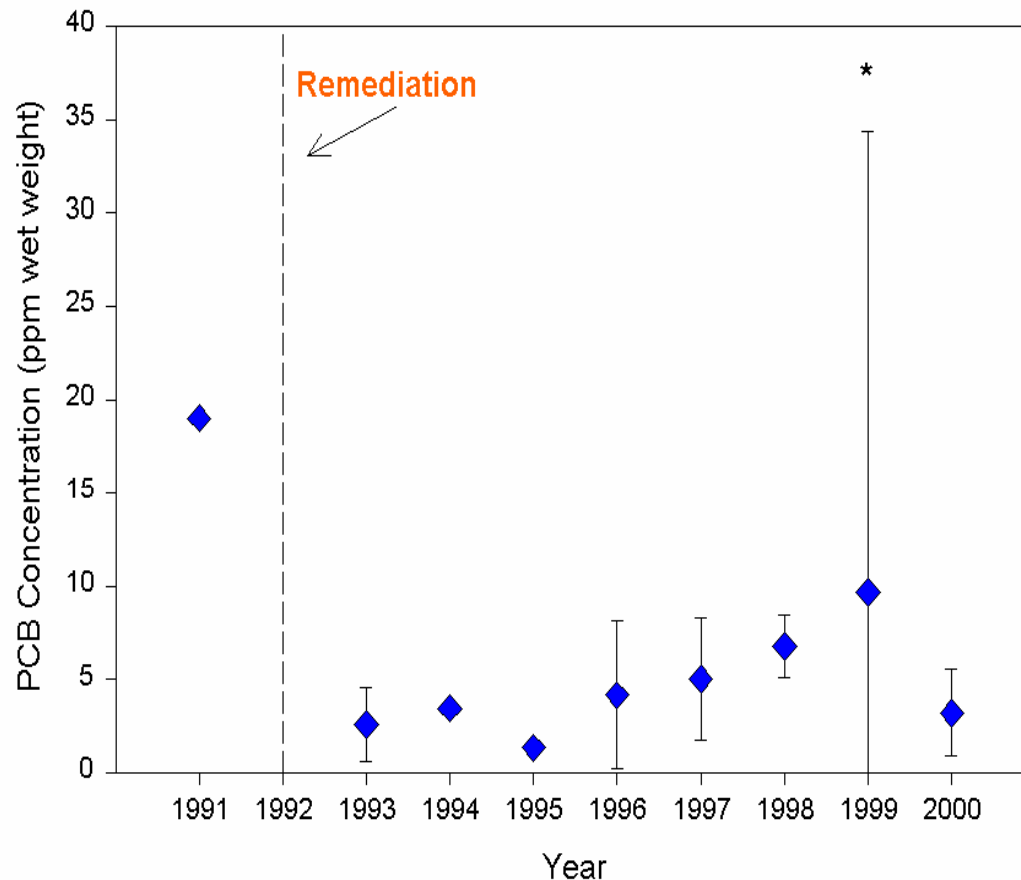
PCB Levels In Carp From Waukegan Harbor Station QZ001 - North Harbor

The inappropriateness of relying on a single data point in 1991 to evaluate the effectiveness of dredging was underscored in 1999, when one sample result out of several taken had 83.8 ppm of PCB. If that fish had been caught in 1993 as the only data point, one would have concluded that dredging caused a 63.8 ppm increase in PCBs in fish in the first post-dredging year!

*83.8 ppm reported in a single carp fillet in 1999.

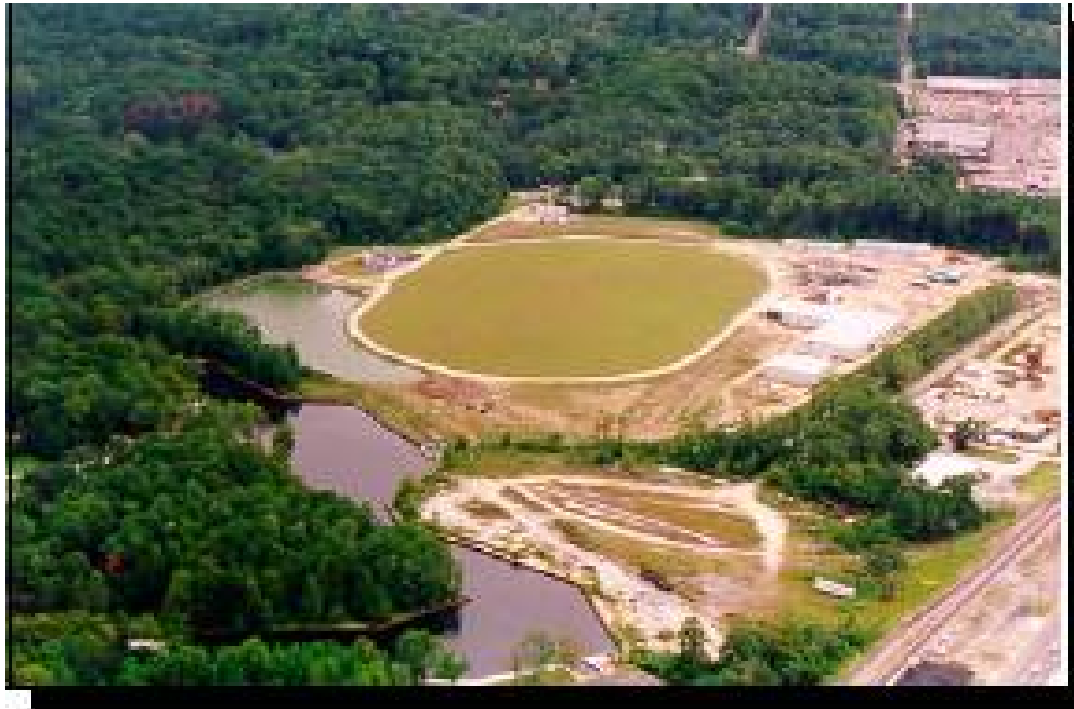
Bayou Bonfouca NPL Site Slidell, LA

- Contaminants of concern:
 - PAHs (creosote)
- Dredged volume (projected/actual):
 - 46,500 cy/170,000 cy
- Project dates:
 - November 1993 - July 1995
- Dredge type/size/number:
 - Single excavator on barge w/ 5.2 cy bucket

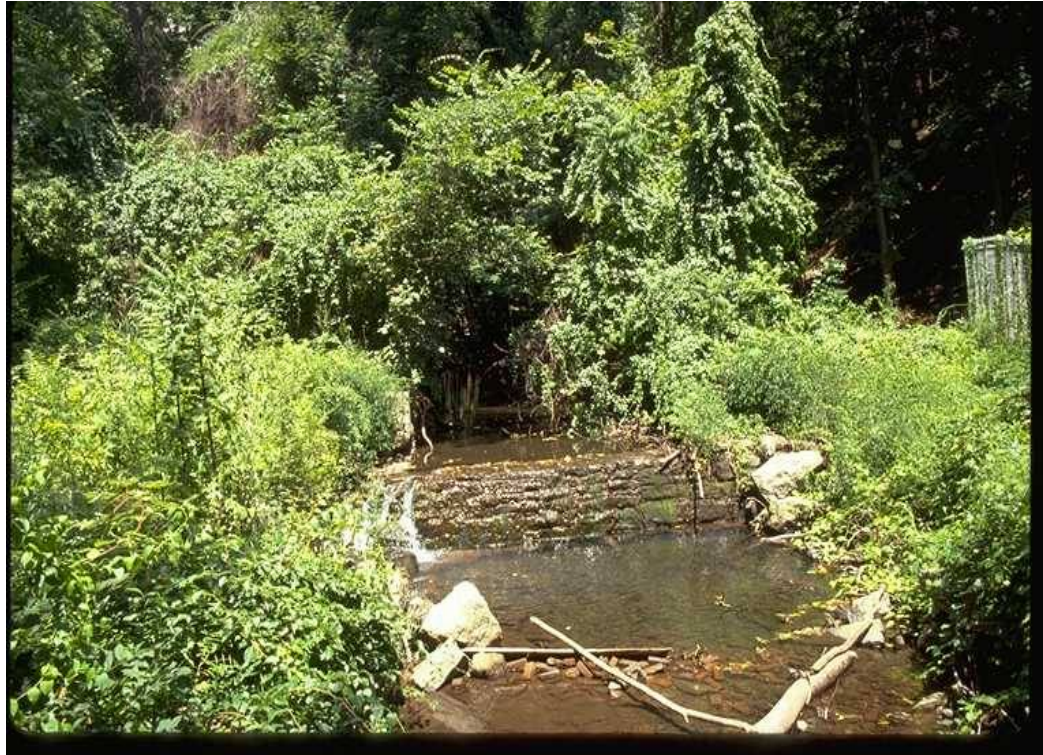
East Foundry Cove Marsh: 12 acres of cattail marsh

East Foundry Cove: 36 acres of tidal flat and cove

East Foundry Cove Pond: 6 acre tidal estuary

West Foundry Cove: slow-flow eddy area
