Installation Restoration Program

2009 Ashumet Pond Update 10 February 2010 MMRCT Meeting

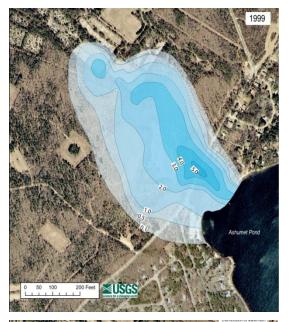
2007 Phosphate Plume

Two new wells (F707 and F421) installed in 2009.

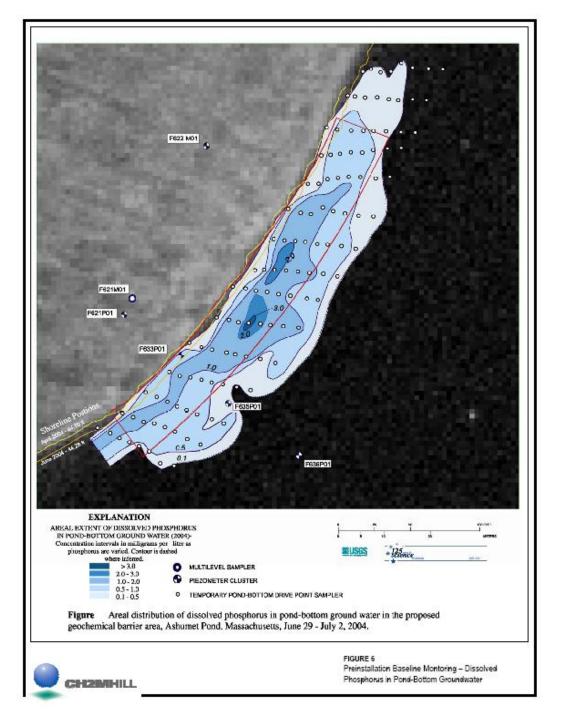
Geochemical Barrier

- The Zero Valent Iron (ZVI) barrier is 300 ft long, 40 ft wide, and 3 ft thick.
- Native sandy sediments mixed with 3% ZVI (by weight) to create permeable barrier along the pond bottom where highest phosphorus levels are discharging.
- The ZVI barrier removes phosphorus from the plume, thereby reducing the levels entering the pond and helping to keep the levels from returning to the higher levels observed prior to the alum treatment.
- The lifespan of ZVI barrier was estimated to be 20-25 years.

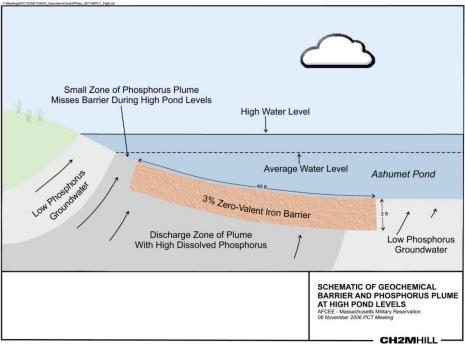
Prior to Installation

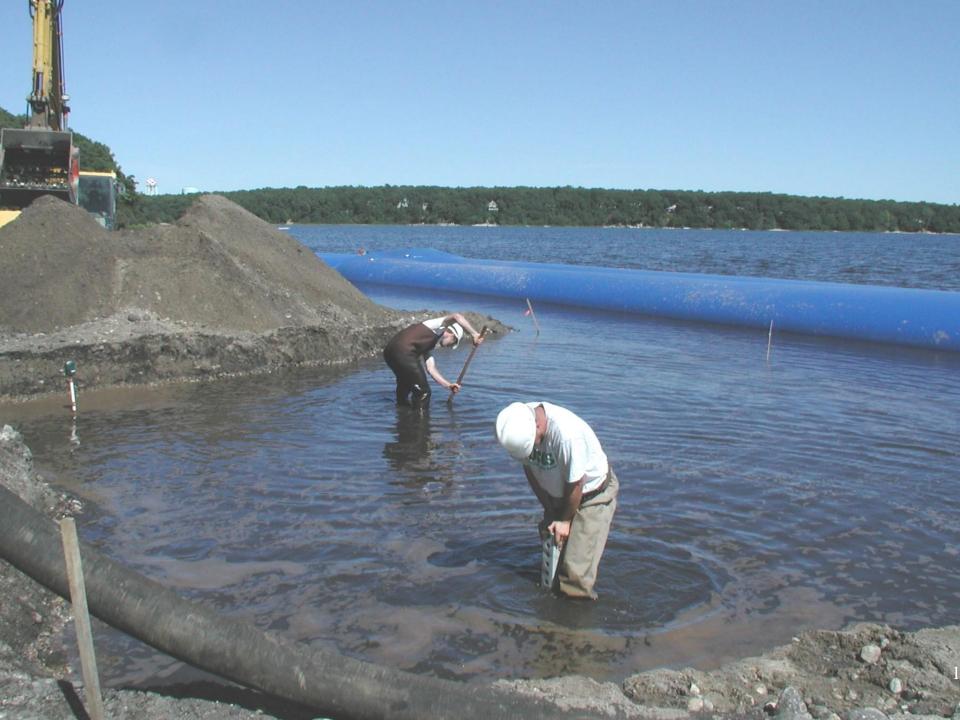
Approx. 1 Year After

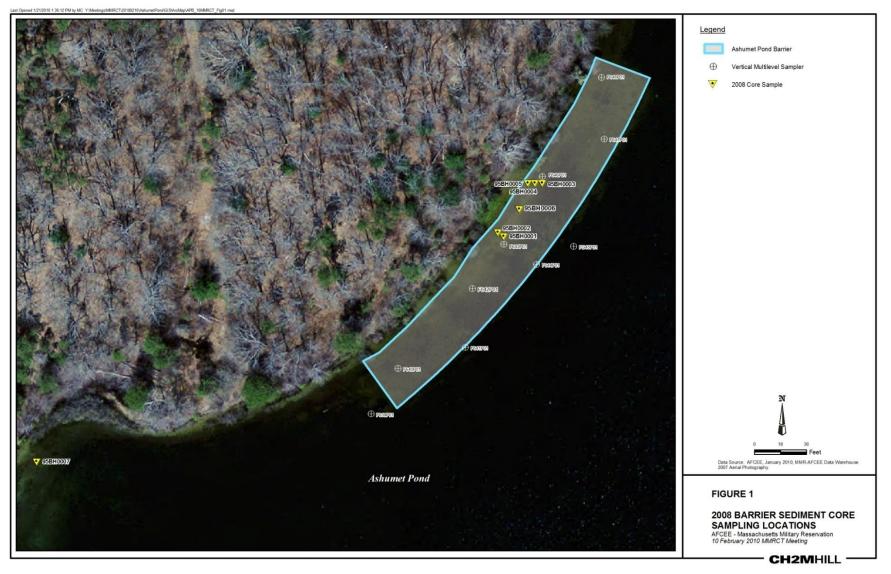
2008 Barrier Core Sampling Locations

- Objectives:
 - Collect cores from representative areas of the barrier.
 - Visually observe the changes in the barrier samples with depth and location.
 - Examine the core materials using a scanning electron microscope and identify how the barrier is removing phosphorus.

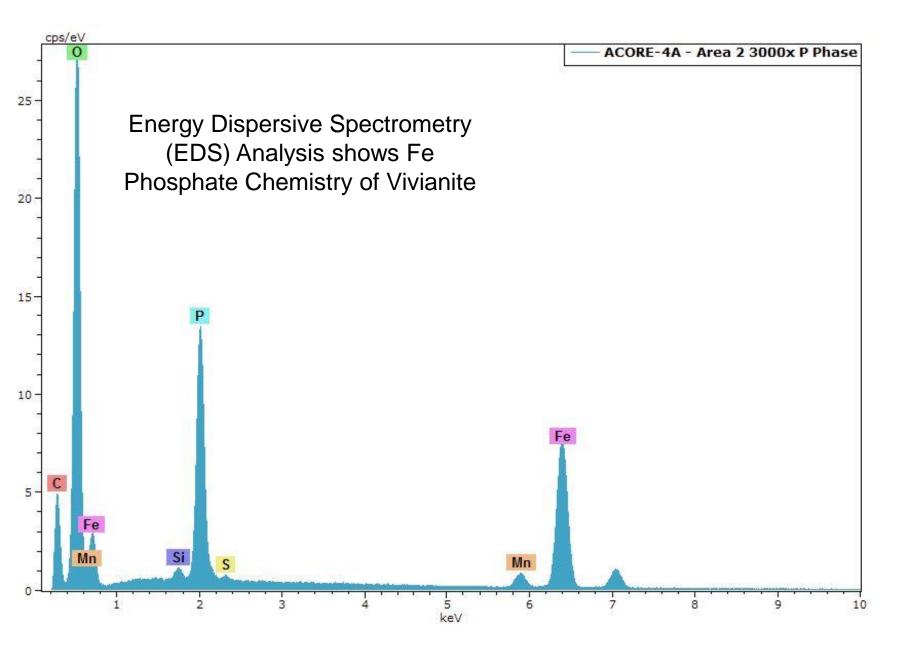
CORE-4A Area 2

High Magnification Image of a Vivianite Crystal growing on the Iron Filing previously shown

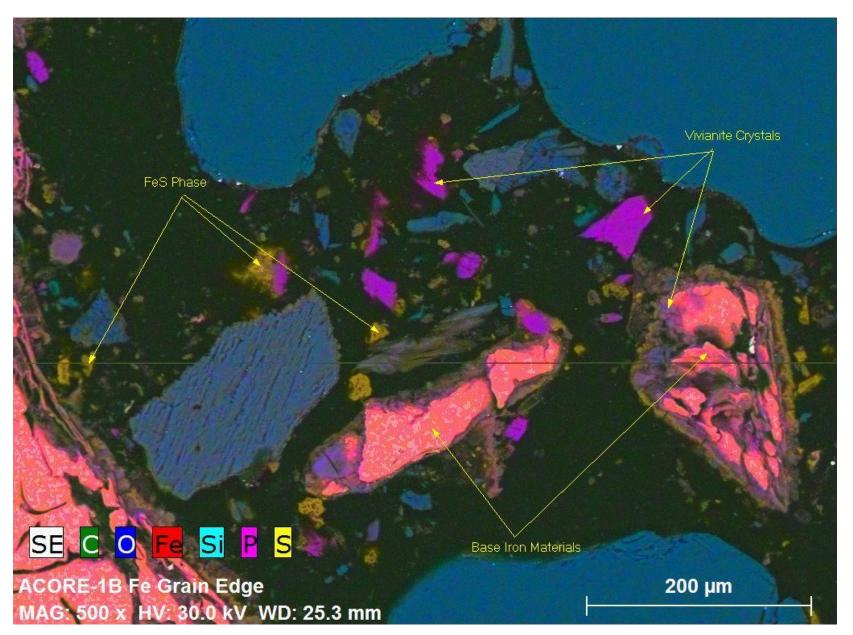
A Core 1B Section 500X Phases

tals with elements color coded ollows: Red = Phosphorus in anite. Light blue is the sulfur in FeS. Darker blue = silica

Vivianite Crystal Rimmed with layer of Iron Sulfide (FeS)

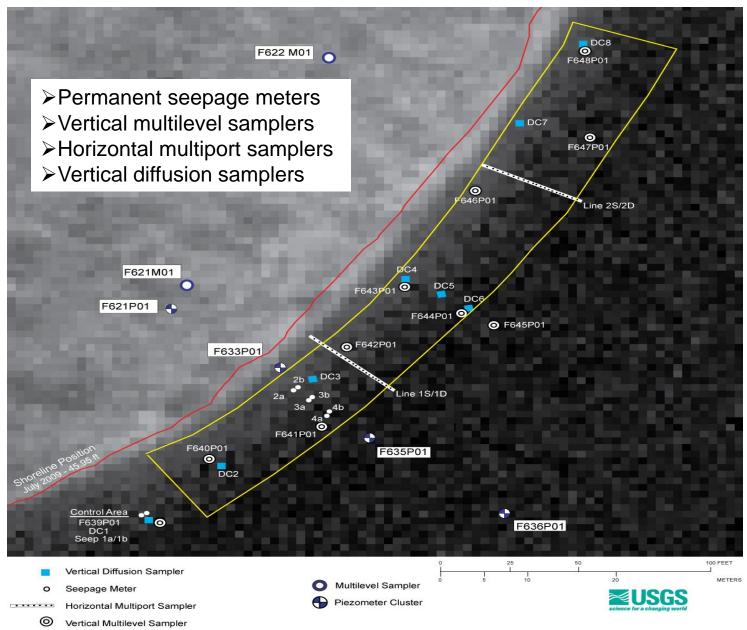
USGS Permanent Sampling Network

- USGS Permanent Monitoring Network and Drive Point Sampling
 - Objectives:
 - Evaluate barrier effectiveness
 - Identify changes in phosphorus levels entering the barrier over time

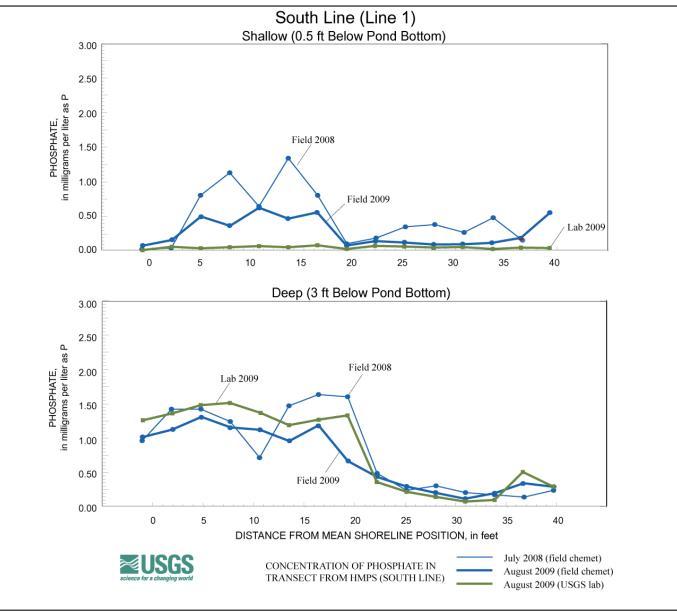
Comparison of 2009 Lab Phosphate Data with 2008 and 2009 Field Phosphate Data

(Southernmost Horizontal Multi-Port Sampler)

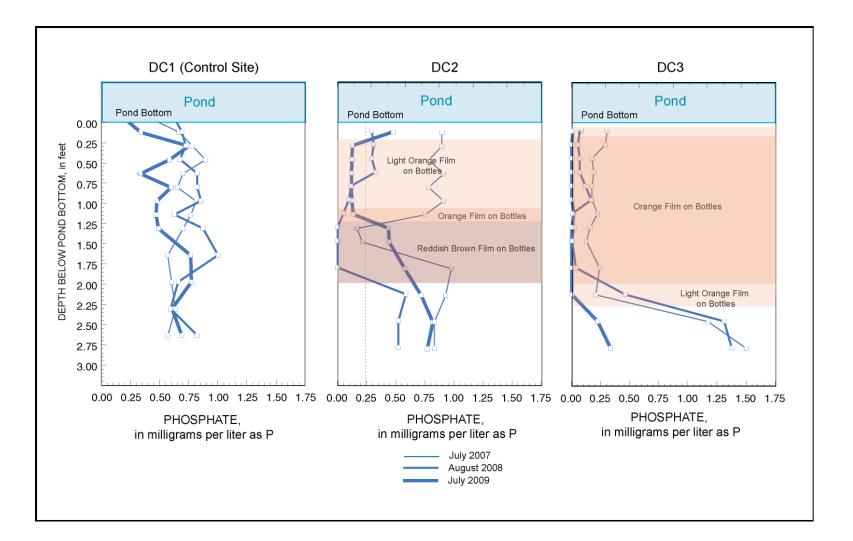
Phosphate Concentration Profiles from Pond-Bottom Vertical Diffusion Chambers (DCs) at 3, 4, and 5 years after PRB Installation

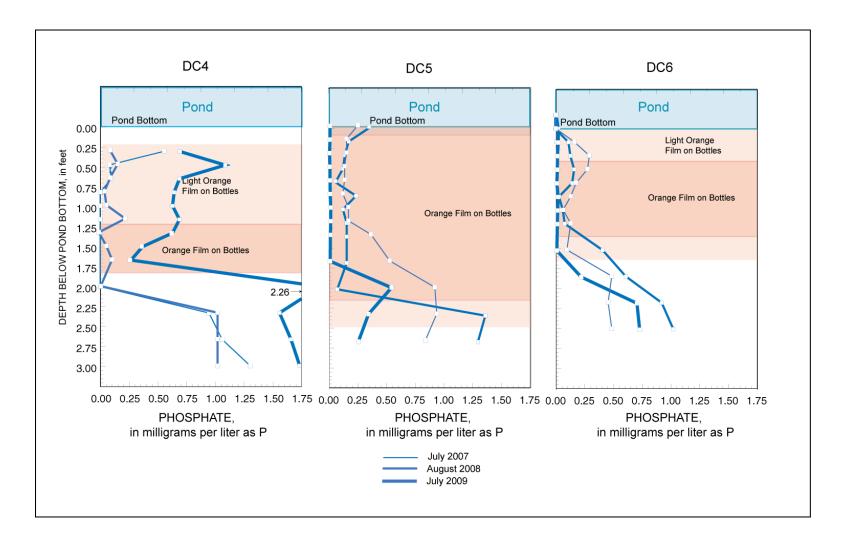
Phosphate Concentration Profiles from Pond-Bottom Vertical Diffusion Chambers (DCs) at 3, 4, and 5 years after PRB Installation

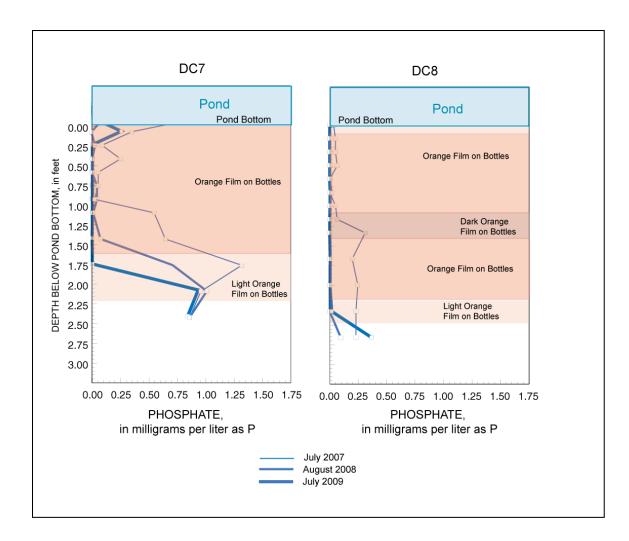
Phosphate Concentration Profiles from Pond-Bottom Vertical Diffusion Chambers (DCs) at 3, 4, and 5 years after PRB Installation

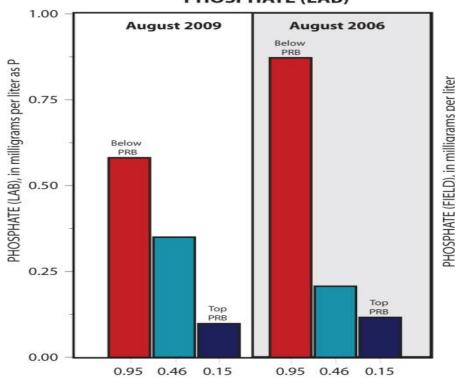
Comparison of Average Phosphorus Entering the Barrier in 2006 and 2009

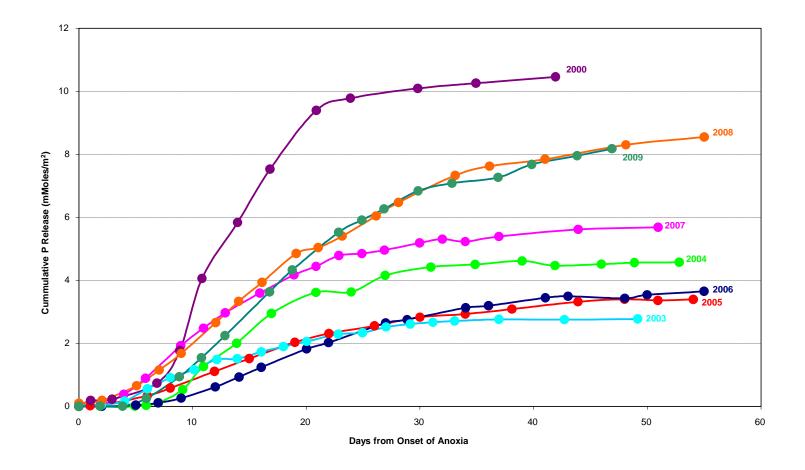
Anaerobic Sediment Release of Phosphorus

Ashumet Pond Deep Basin ~ 18.0 m depth

Laboratory tests of 2008 pond sediment core samples produced the highest release of phosphorus observed since the alum treatment.
