FINAL REPORT

Treatment of RDX & HMX Plumes Using Mulch Biowalls

ESTCP Project ER-0426

Dr. Charles Newell
GSI Environmental, Inc.

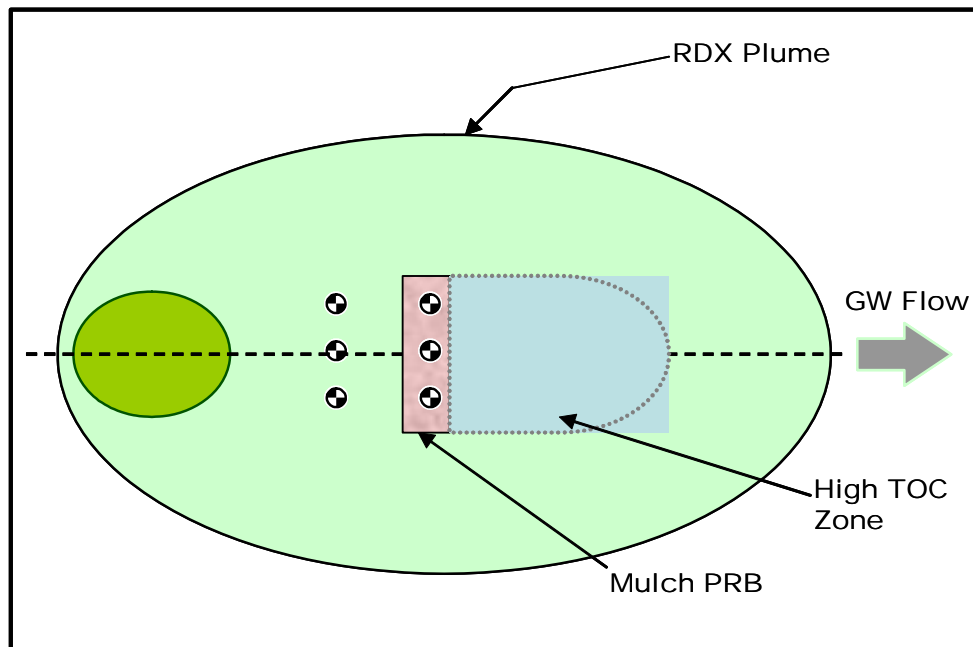
Figure 4. Plan View Schematic of Mulch Wall Implementation Concept.

Although the possibility of toxic intermediate generation exists with all reductive remediation technologies, numerous studies^{8, 19, 21, 39} have shown that the generation of intermediates is short-lived as they are rapidly degraded. The column treatability study for this project conducted earlier confirmed that reductive intermediates of RDX were present only at trace levels in the column effluent. In the pilot-scale field demonstration the reactive zone will extend well beyond the PRB wall as dissolved organic carbon is generated from the mulch and is consumed downgradient of the PRB (Figure 4).

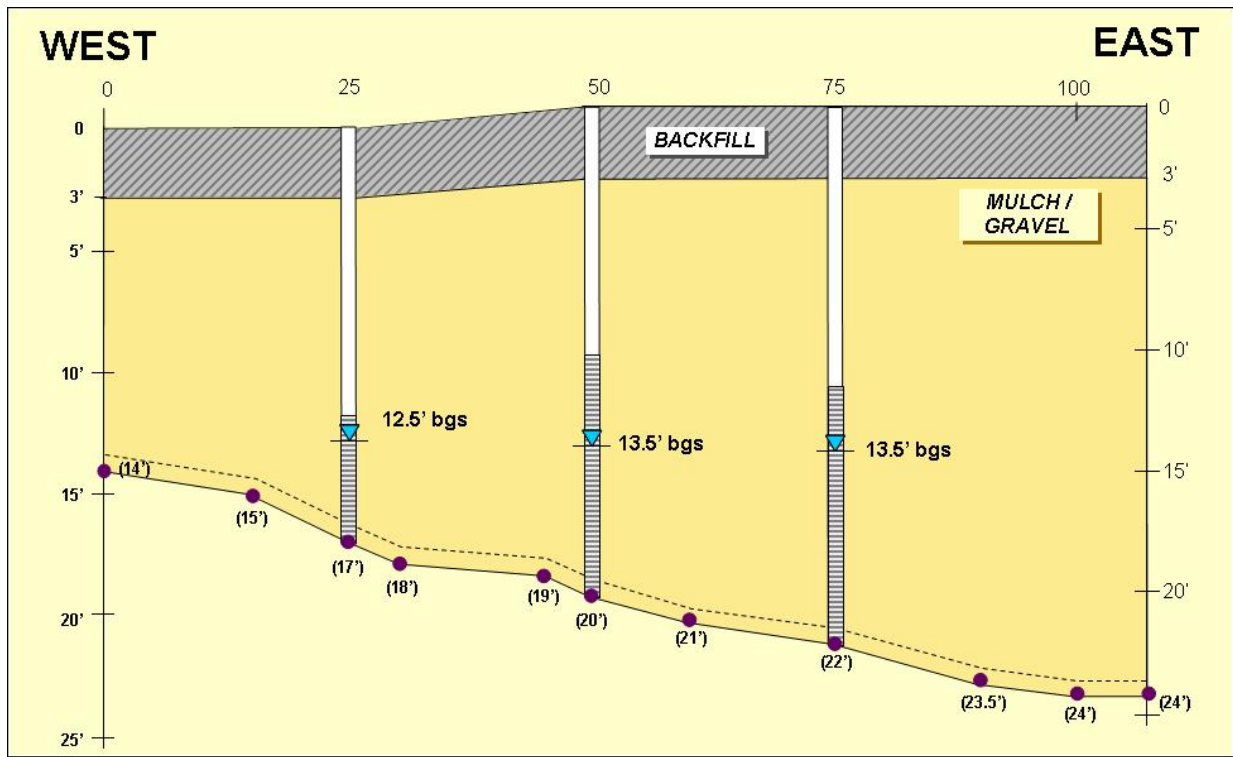
Figure 12. Cross-section of the Pilot Scale Mulch PRB at the PCD SWMU-17 Area.

Note that the bentonite funnel wall intersects the mulch PRB between the 100-ft and 105-ft mark at an approximate angle of 35 degrees (not shown). The dotted line near the base of the PRB indicates the original location of the Pierre shale bedrock; the PRB was keyed-in approximately 1 foot into the bedrock.

For the pilot-scale demonstration, an estimated 17.2 gal/hr (2.3 ft³/hr) of contaminated groundwater was treated, reducing the peak influent RDX concentration of 2-3 ppb to less than the analytical reporting limit of 0.2 ppb (below the regulatory threshold of 0.55 ppb) in the effluent. Peak groundwater influent concentrations were found to be significantly lower than those measured as part of the site investigation activities. The mass removal rate corresponding to these mass loadings was approximately 8.3E-6 lb/day or 3.0E-3 lb/year. Additional assumptions used in this calculation included a hydraulic conductivity of 0.006 cm/s, a hydraulic gradient of 0.005 ft/ft, and the saturated cross-section estimated from Figure 12.

zone because of a rise in the bedrock elevation (Figures 8 and 12). The RDX concentrations in the plume are highest along the interface with the unsaturated zone (Figure 14).

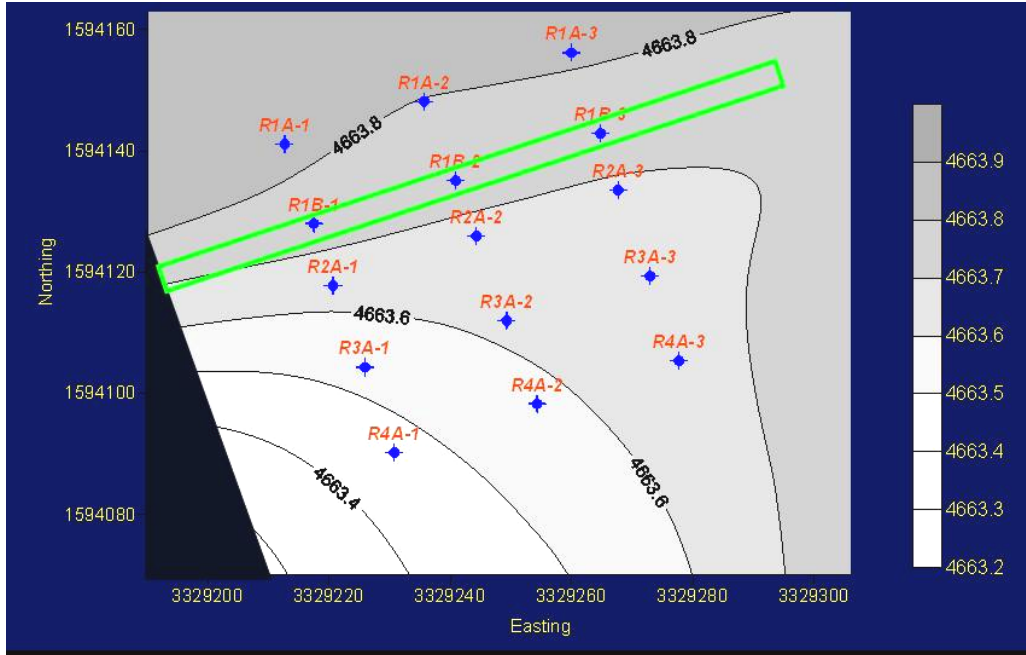
Figure 13. Potentiometric Surface Based on Hydraulic Heads Measured on December 2, 2005, 2.5 Weeks after Technology Implementation.

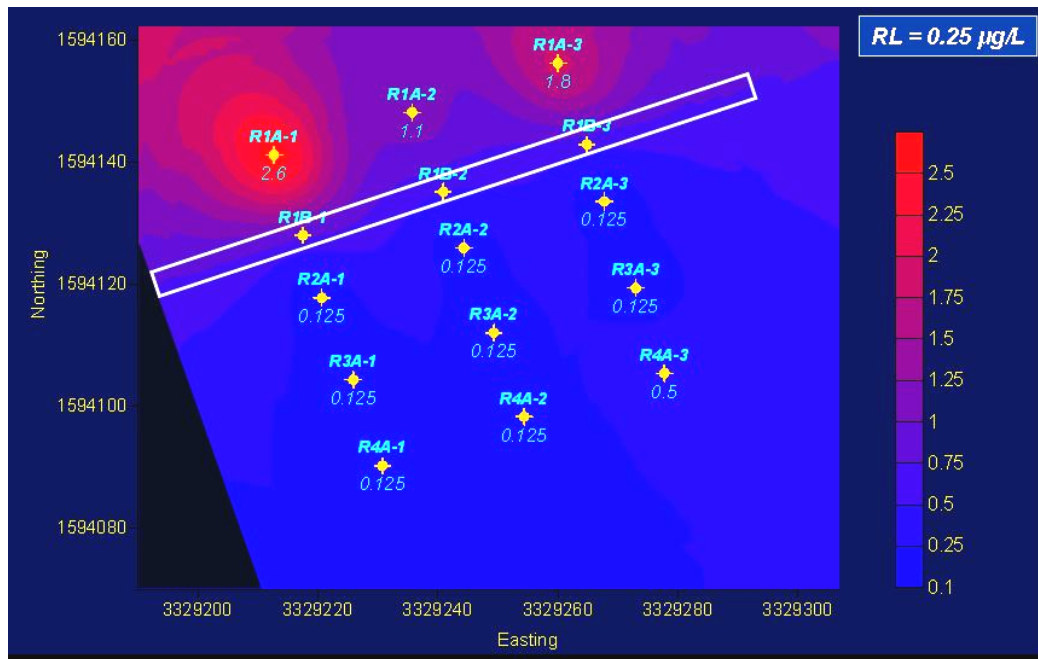
Figure 16. RDX Concentrations Measured on June 20, 2006, 7 Months After Mulch PRB Installation. RDX detected in only one downgradient well (R4A-3) at a concentration less than the regulated level.

By the second post-installation monitoring event on June 20, 2006, almost 31 weeks after the PRB installation, approximately 6 system pore volumes had been displaced. By this time, the system appeared to be approaching a steady state, and RDX could not be detected in any of the wells except well R4A-3, where it was below the regulatory threshold of 0.55 ppb (Fig. 16).

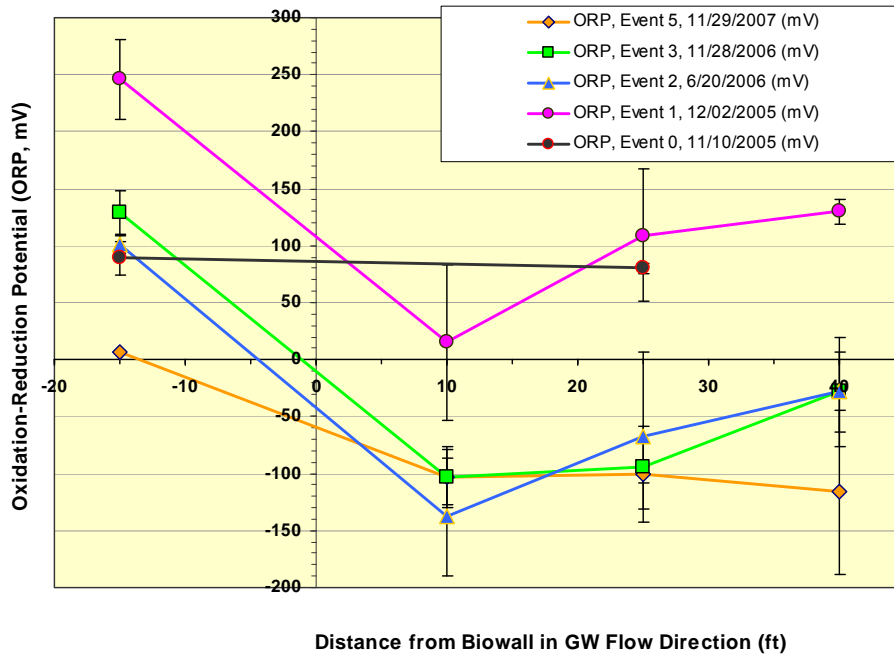
Figure 17. Oxidation-reduction Potential (ORP) Measurement Averaged Over Different Well-rows. Data is Presented as Transects Along the Direction of Groundwater Flow, Tangential to the Mulch PRB axis. Error Bars (Figures 17-21) Represent \pm standard Deviation from the Average Value at Each Row. Wells Downgradient of the Mulch PRB Met the $<+50$ mV Limit Listed Earlier as One of the Criteria Defining the “treatment zone”. Note that Data from the July 18, 2007 Event is Not Shown Because of a Systematic Calibration Error that Resulted in ORP Readings 100 mV Lower Than Expected. Instead, the Figure Shows Data from a 5th Monitoring Event Conducted in November 2007 to Ensure That System Breakthrough Was not Occurring.

The first criterion was easily satisfied by all field demonstration monitoring wells downgradient of the mulch PRB (Figure 17), after the first post-installation (non-steady-state) monitoring event in December 2005. The +50 mV value has been listed in literature as a threshold value for aerobic activity of facultative organisms³².

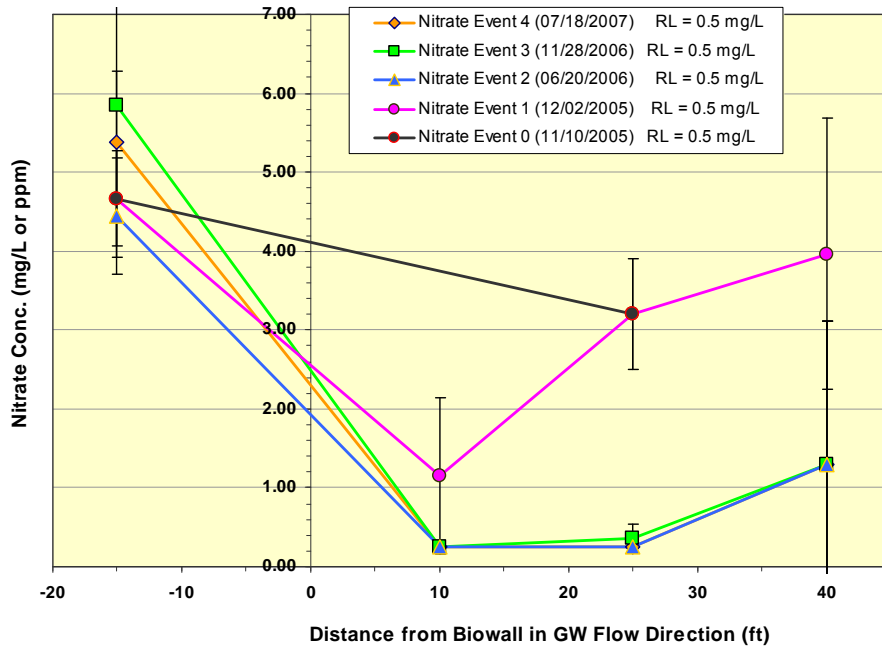
Figure 18. Row-averaged Nitrate Concentrations Over the Course of the Demonstration. Nitrate Reducing Conditions Were Established in All Downgradient Wells By the Second Post-PRB Monitoring Event in June 2006. Note That Nitrate is Preferentially Reduced Compared to RDX.

Geochemical indicators of reducing conditions were evident in the treatment zone downgradient of the mulch PRB. Background nitrate levels of approximately 4–6 mg/L were found to fall below detection levels downgradient of the PRB (Figure 18) in all wells except for R4A-3, which appeared to be influenced a more lateral (East-to-West) direction of groundwater flow. The reduction reaction of nitrate to nitrite is known to have a higher mid-point redox than RDX reduction, indicating that nitrate is preferentially reduced compared to RDX. Sulfate reducing conditions were also present downgradient of the PRB (Figure 19) after the December 2005 monitoring event, when the freshly installed mulch PRB appeared to temporarily release sulfate into the groundwater; however, strong sulfate reducing conditions for the 106 mg/L background sulfate in the groundwater at SWMU-17 existed only in Rows R2A and R3A. Concentrations approached background levels by Row R4A. Since RDX reduction occurs somewhere between nitrate and sulfate reducing conditions, it is best to select the less preferred electron acceptor for setting the edge of the treatment zone. Using this approach, RDX reduction is ensured within the defined treatment zone. Hence, the treatment zone was defined as the area that included Row R2A and R3A wells, but not R4A wells.

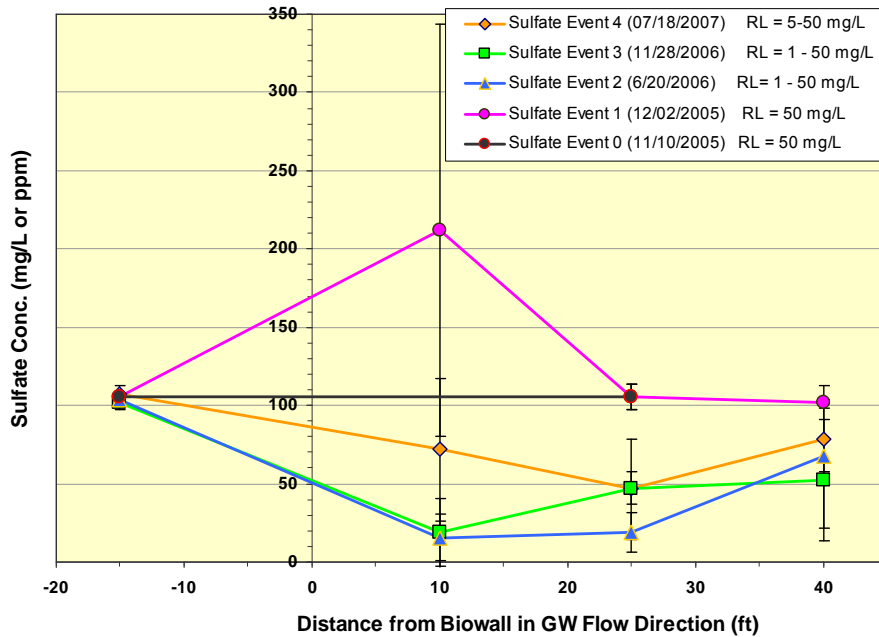
Figure 19. Row-averaged Sulfate Concentrations Over the Course of the Demonstration. Strong Sulfate Reducing Conditions Existed in Downgradient Row R2A and R3A Wells by June 2006.

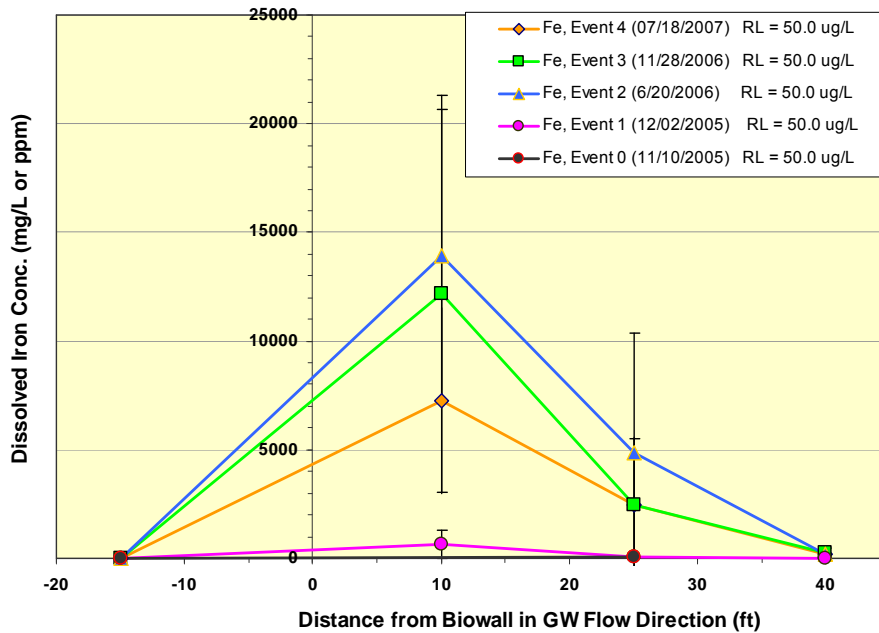
Figure 20. Row-averaged Dissolved Iron Concentrations Transects Over the Course of the Demonstration. Ferrous Iron was Mobilized From the Aquifer Matrix by the Reduction of Insoluble Ferric Iron.

Metals mobilized by a reduction from their insoluble oxidized form to their reduced soluble form corroborated the extent of the treatment zone defined by sulfate reduction. Both total iron (Figure 20) and total arsenic (Figure 21) were observed to rise sharply above their background levels immediately downgradient of the mulch PRB in Row R2A wells. These elevated concentrations subsided by the time they reached the farthest downgradient Row R4A wells via re-oxidation and precipitation back into the aquifer matrix. These findings further indicated that the edge of the treatment zone existed between the Row R3A and R4A wells. Release of naturally-occurring arsenic above the Arsenic Rule threshold of 10 ppb proved to be problematic, as purge water generated from sampling Row R2A and R3A wells could not be treated using the GETI treatment system at PCD.

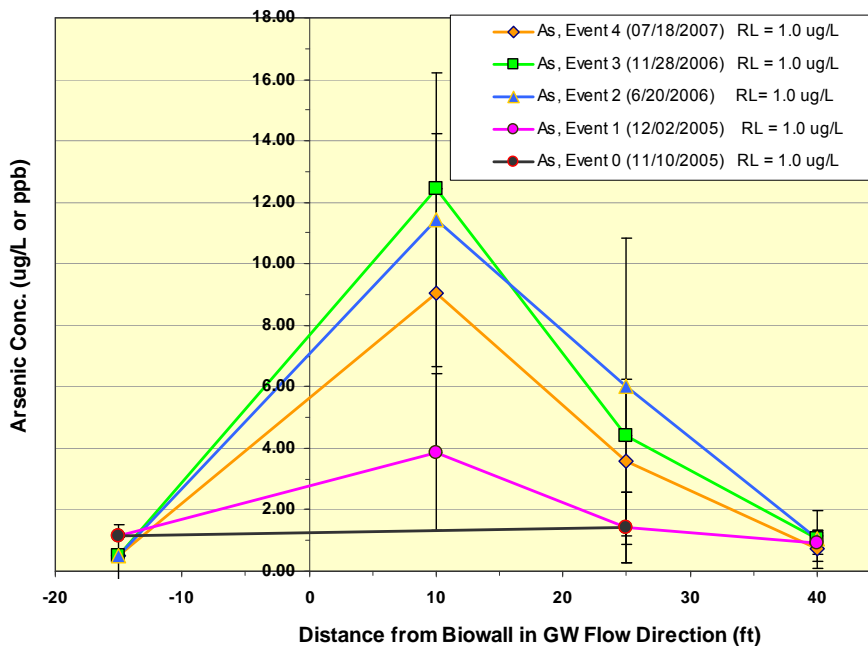
Figure 21. Row-averaged Total Arsenic Concentrations Over the Course of the Demonstration. Arsenic was Mobilized From by the Reduction of the Aquifer matrix. The Pattern was Similar to That Observed for Iron Concentration. Arsenic Concentrations Returned to Background Levels by Row R4A Wells.
